Reference: **Preliminary Slope Evaluation – The Reserves at Parklands Phase 2**
8000 Broad Run Road
Louisville, Jefferson County, Kentucky 40291
ECS Project No. 61-3295

Visual Reconnaissance of Selected Slope Areas

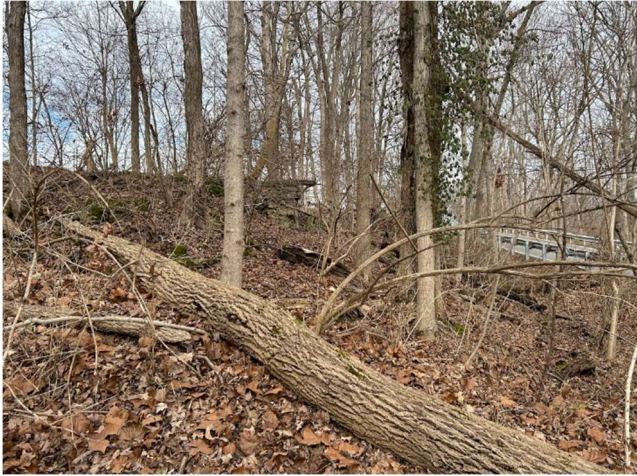
Typical slope at Area 1 east of Lot 270

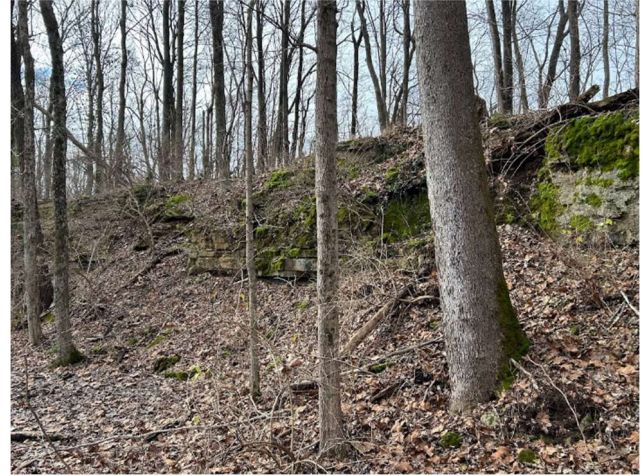
Rock outcrop at Area 1 east of Lot 270

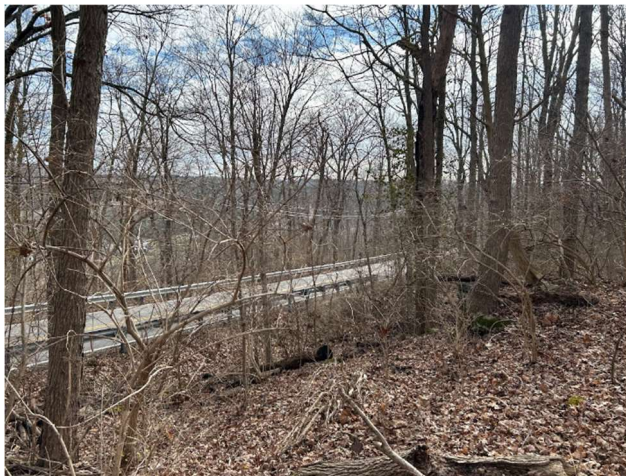
View of slope near Broad Run Road at Area 1 east of Lot 270

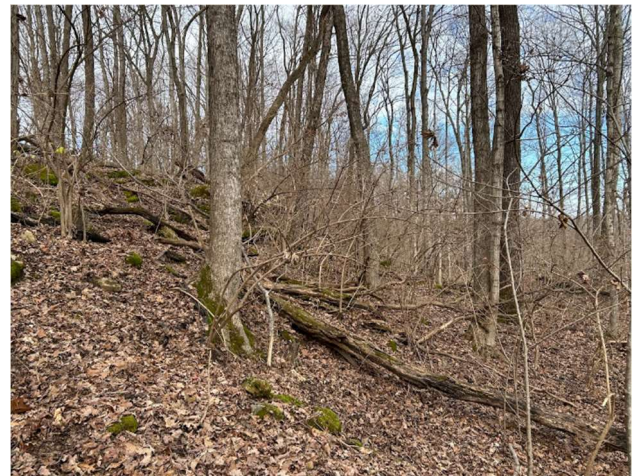
View of bent and leaning trees at Area 2 near Lots 247 and 248

The observed conditions indicated past slope instability along the hillside, including the sparsely observed bent trees which appeared to be the result of slope movement that occurred several years prior to this site visit based on the tilt and bow of trees observed. The lack of any obvious tension cracks or scarps along the slope surface does not suggest rapid, recent slope movement. Due to the time of year of our visual reconnaissance, the presence of bedding of fallen leaves across much of the hillside prevented a thorough observation of the slopes in portions of the area of interest. While additional evidence of slope instability was not observed, it is possible that the dense ground cover obscured the presence of slope instability. Once areas where site disturbance for grading and/or utility installation have been cleared of dense vegetation, ECS should be retained to further evaluate those slopes. Significant disturbance of the steeper slopes along the hillside should be avoided if possible. If large excavations or significant re-grading in those areas are to occur, ECS should be contacted for guidance.

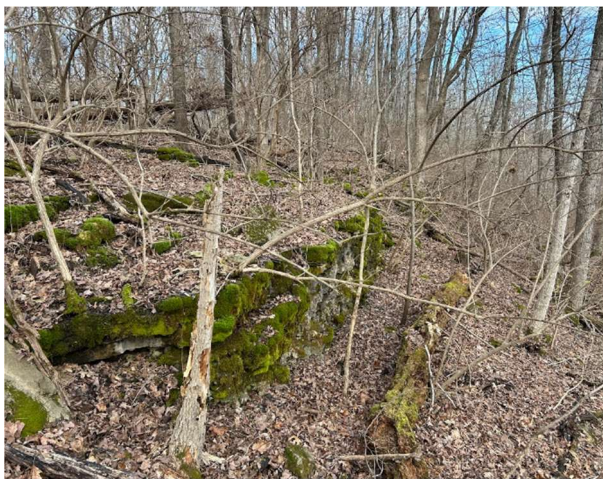
Rock outcrop along slope at Area 2 near Lots 247 and 248

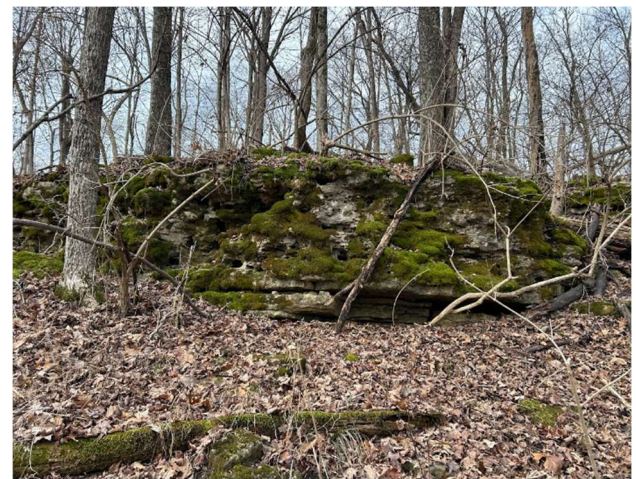
Rock outcrop along slope at Area 2 near Lots 247 and 248

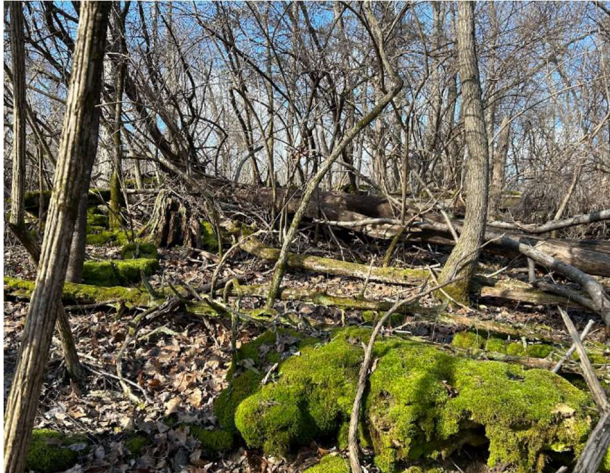
View of bent tree and rock outcropping at Area 3 near Lot 221

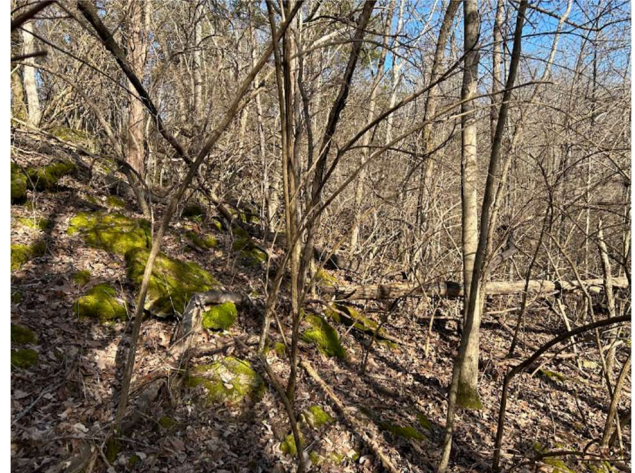
Typical slope along hillside at Area 3 near Lots 221

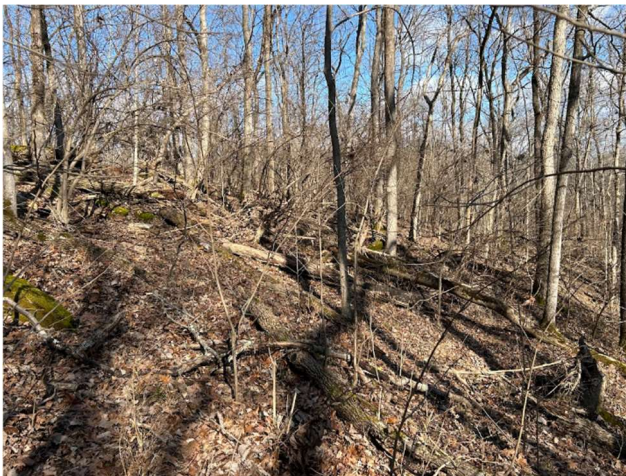
Typical slope at Area 3 near Lot 221

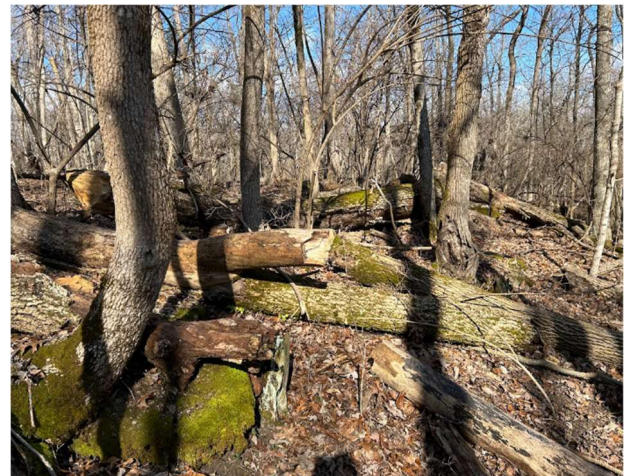
View of bent tree at Area 3 near Lot 221
