**GREENBAUM ASSOCIATES, INC.**  
**GEOTECHNICAL & MATERIALS ENGINEERS**

April 25, 2021

**Re: Slope Survey**  
**Garrett Bridwell Subdivision**  
**Old Heady Road**  
**Louisville, Kentucky**  
**Project Number 21-089E**

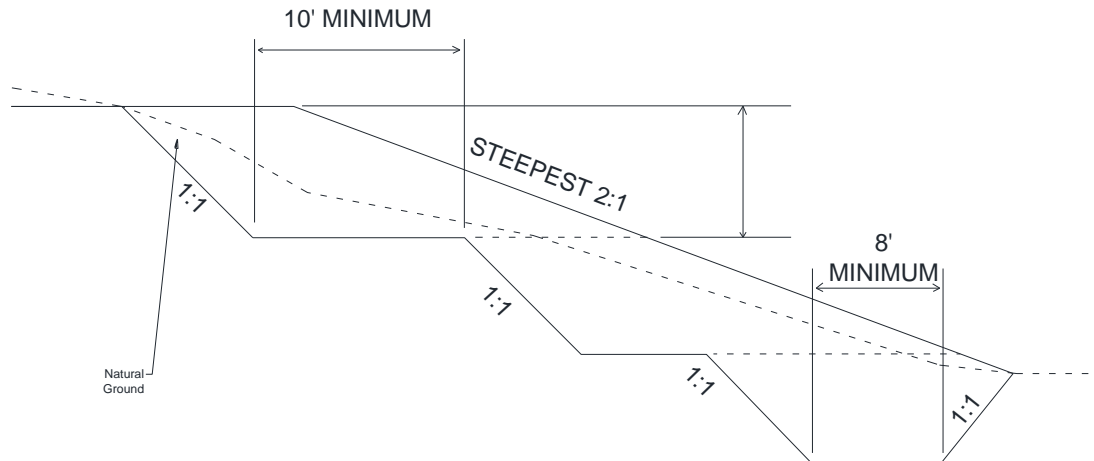
The topography of this property is rolling, resulting in substantial cuts and fills. When fill is to be placed on an existing slope it is imperative that the existing slope be benched as shown in the diagram below to prevent the formation of a plane of weakness along which a slope failure can develop. Benching will have to be adjusted as necessary, in consultation

with this office, where limestone bedrock is encountered that prevents benching as shown from being achieved

Soil fill must be no steeper than 2 horizontal to 1 vertical in order that it remain stable. Where there is a sharp angle in the slope, such as near the corner of a building or pavement corner, the slope must be no steeper than 2.5 to 1. If the slope is to be mowed with normal lawncare equipment, it should be no steeper than 3 to 1. This survey is intended to address existing slopes at this site. This is not a geotechnical investigation and does not include any boring, laboratory testing nor modeling of slope stability to determine factor of safety against sliding.

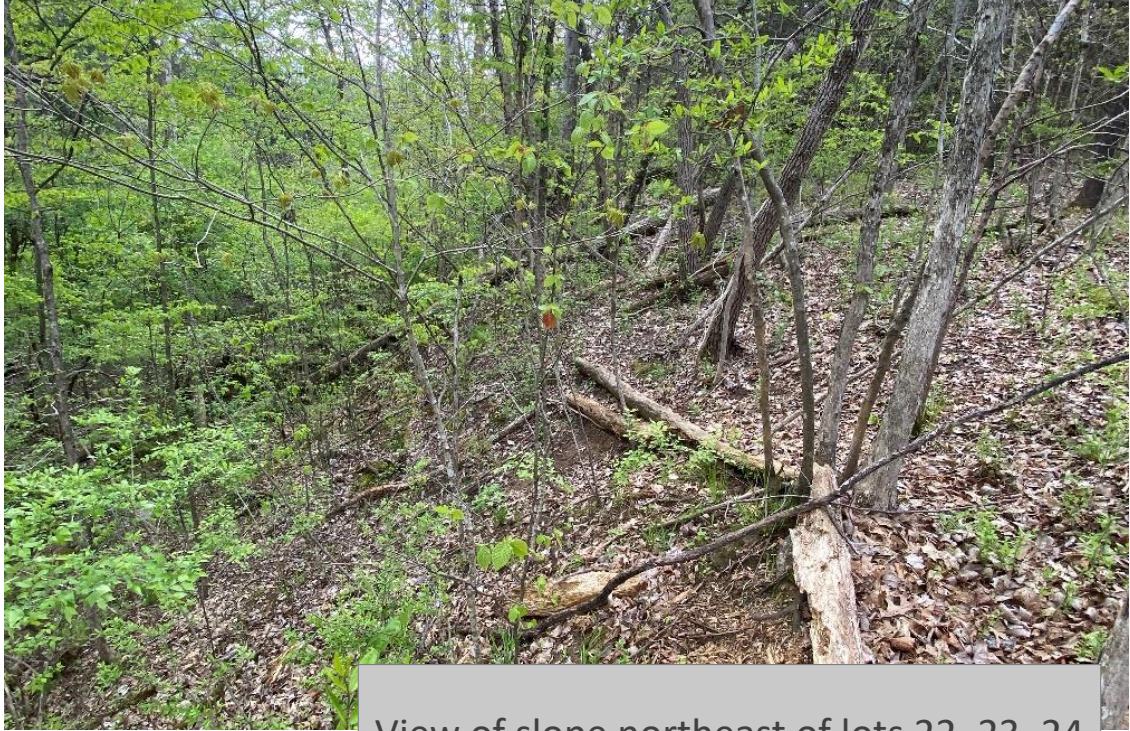
View of slope northeast of lots 22, 23, 24

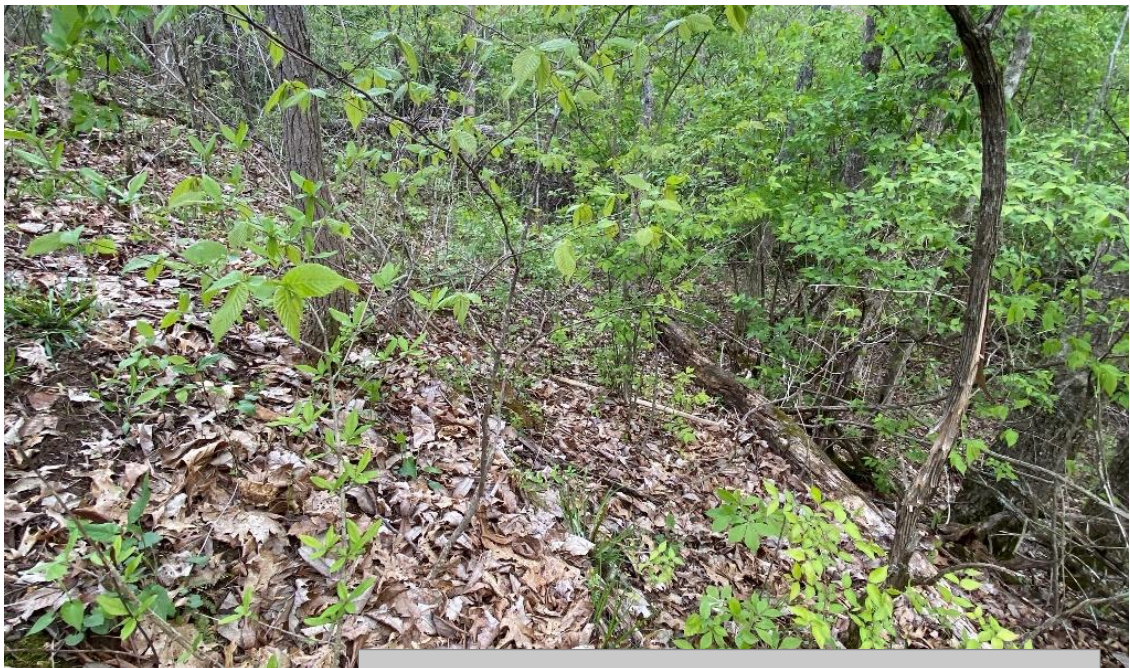
View of slope northeast of lot 24

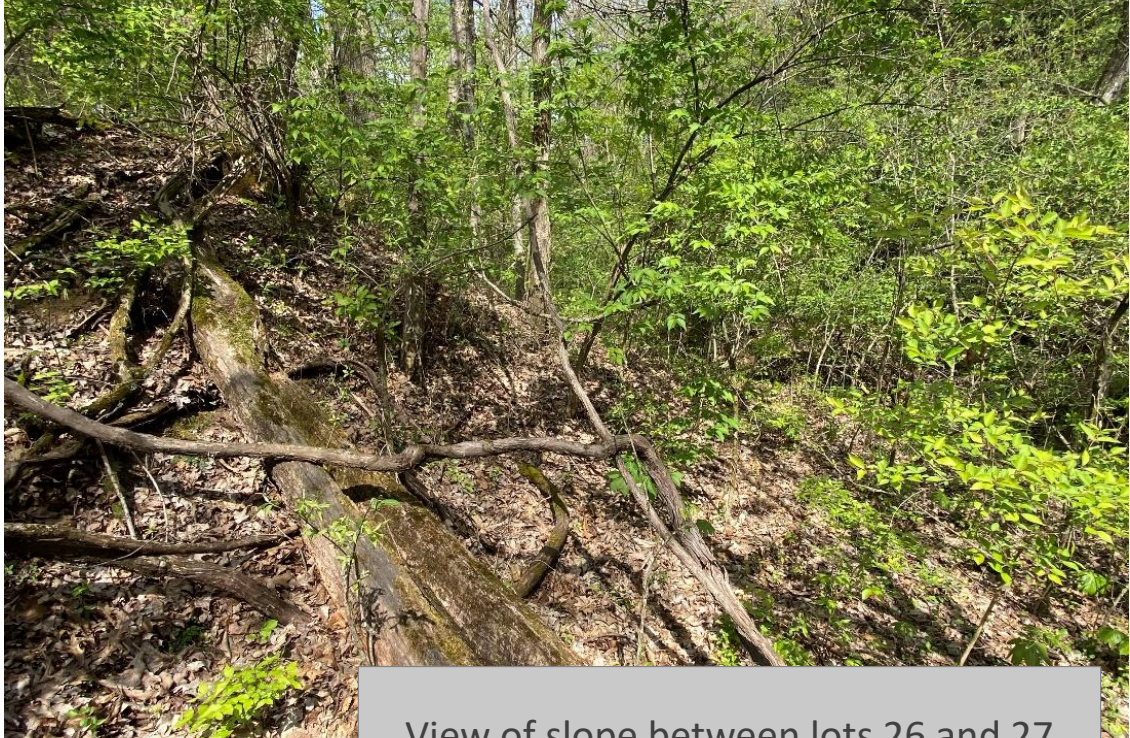
View of slope between lots 26 and 27

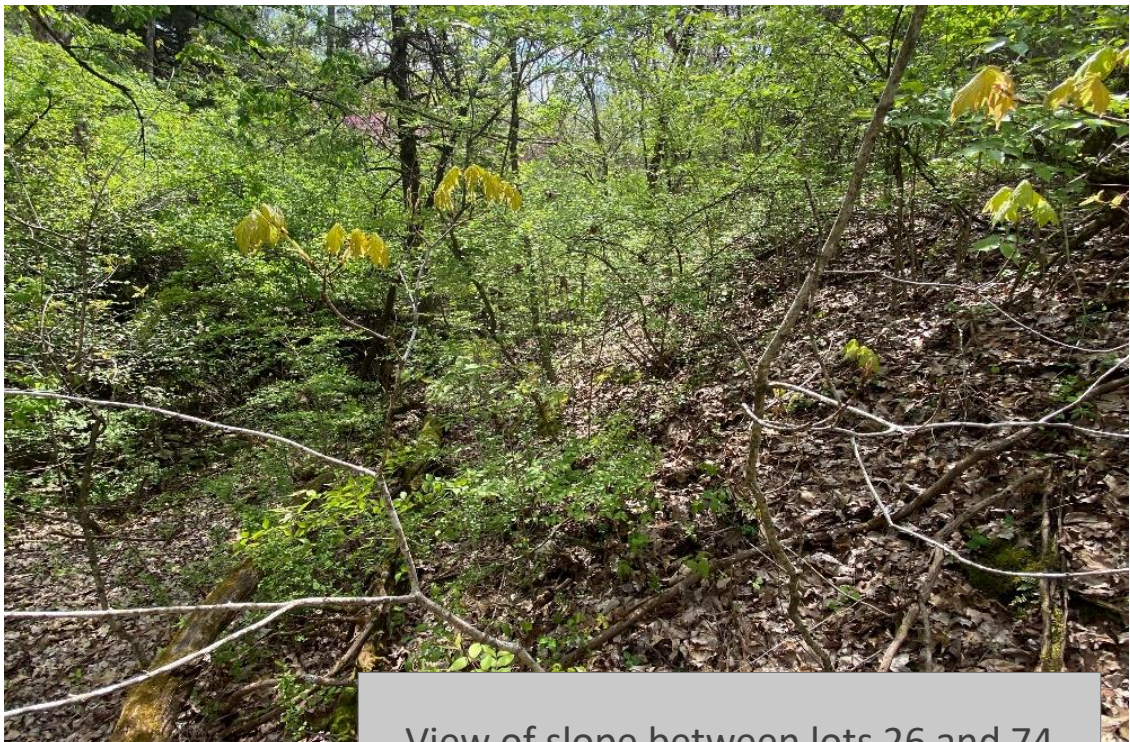
View of slope between lots 26 and 74

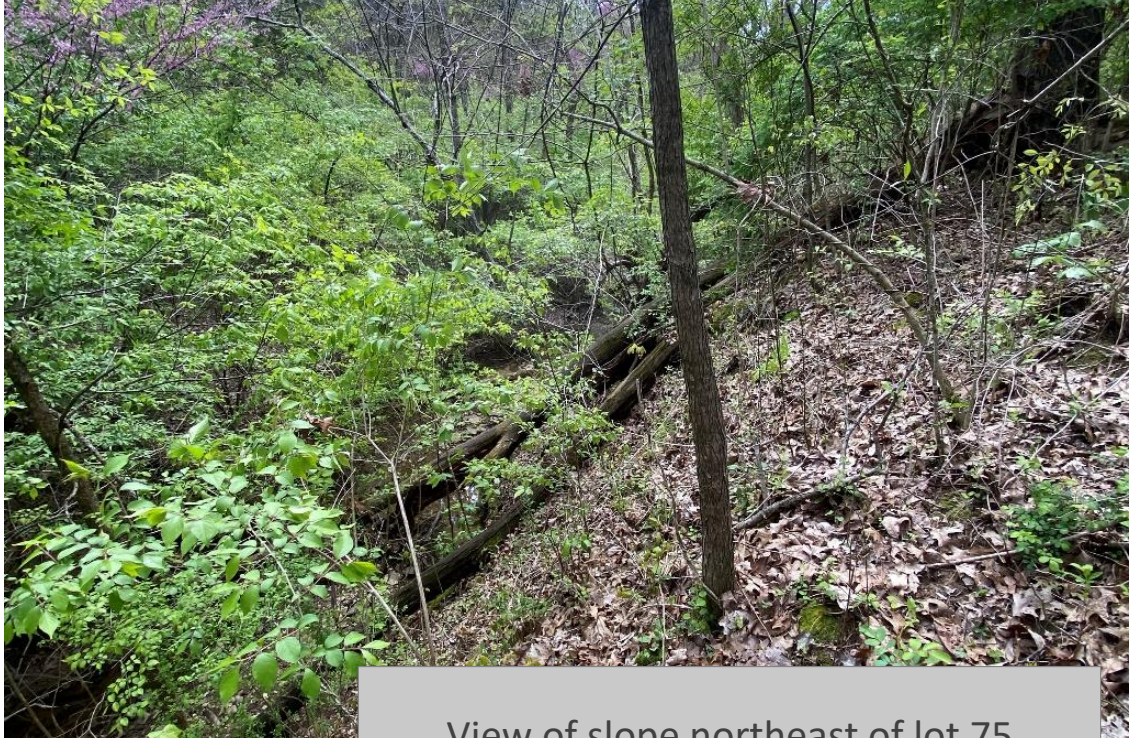
View of slope northeast of lot 75

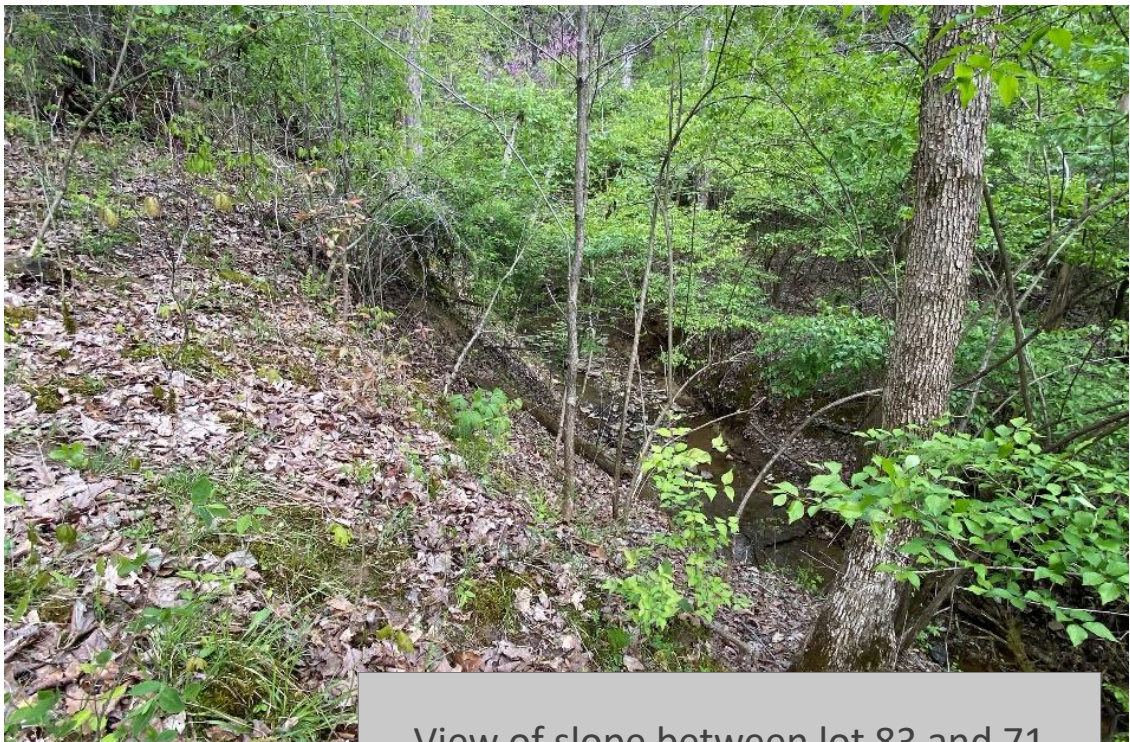
View of slope between lot 83 and 71

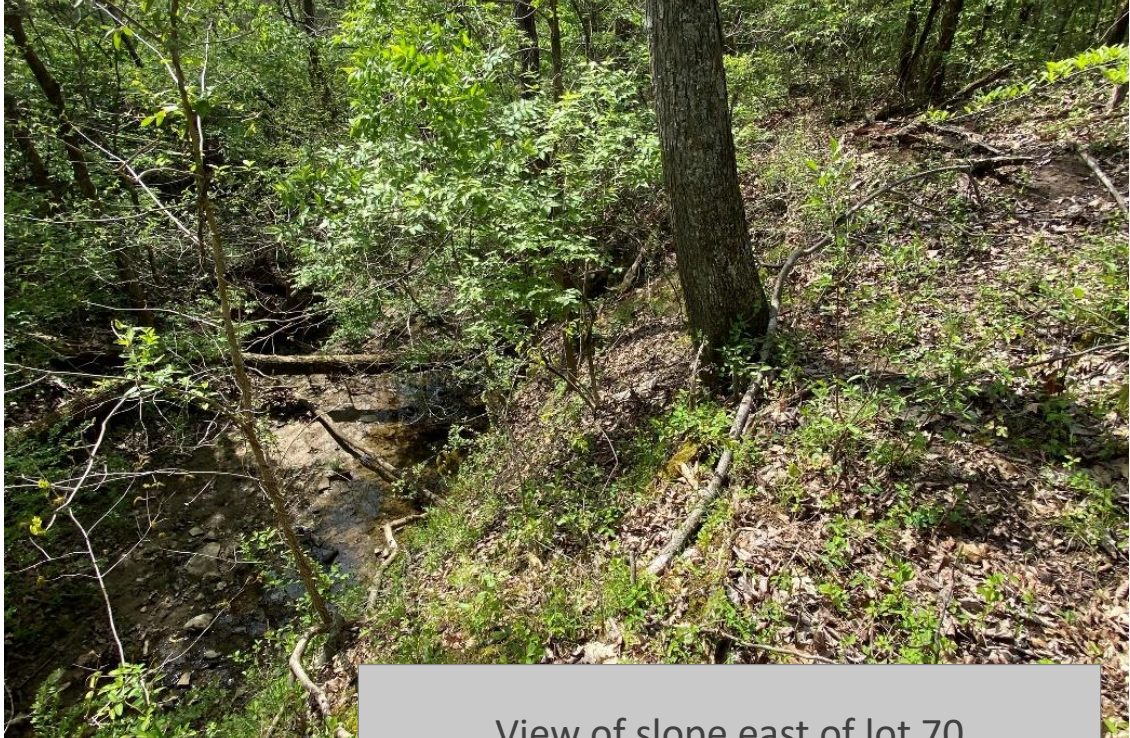
View of slope east of lot 70

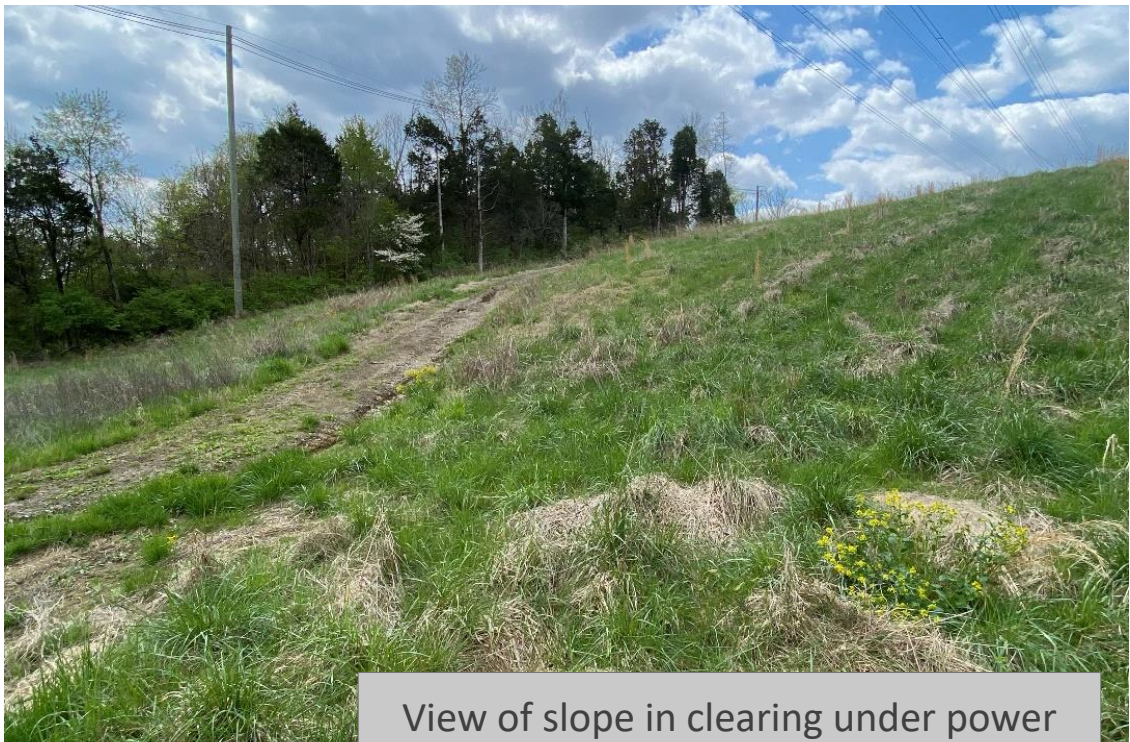
View of slope in clearing under power lines

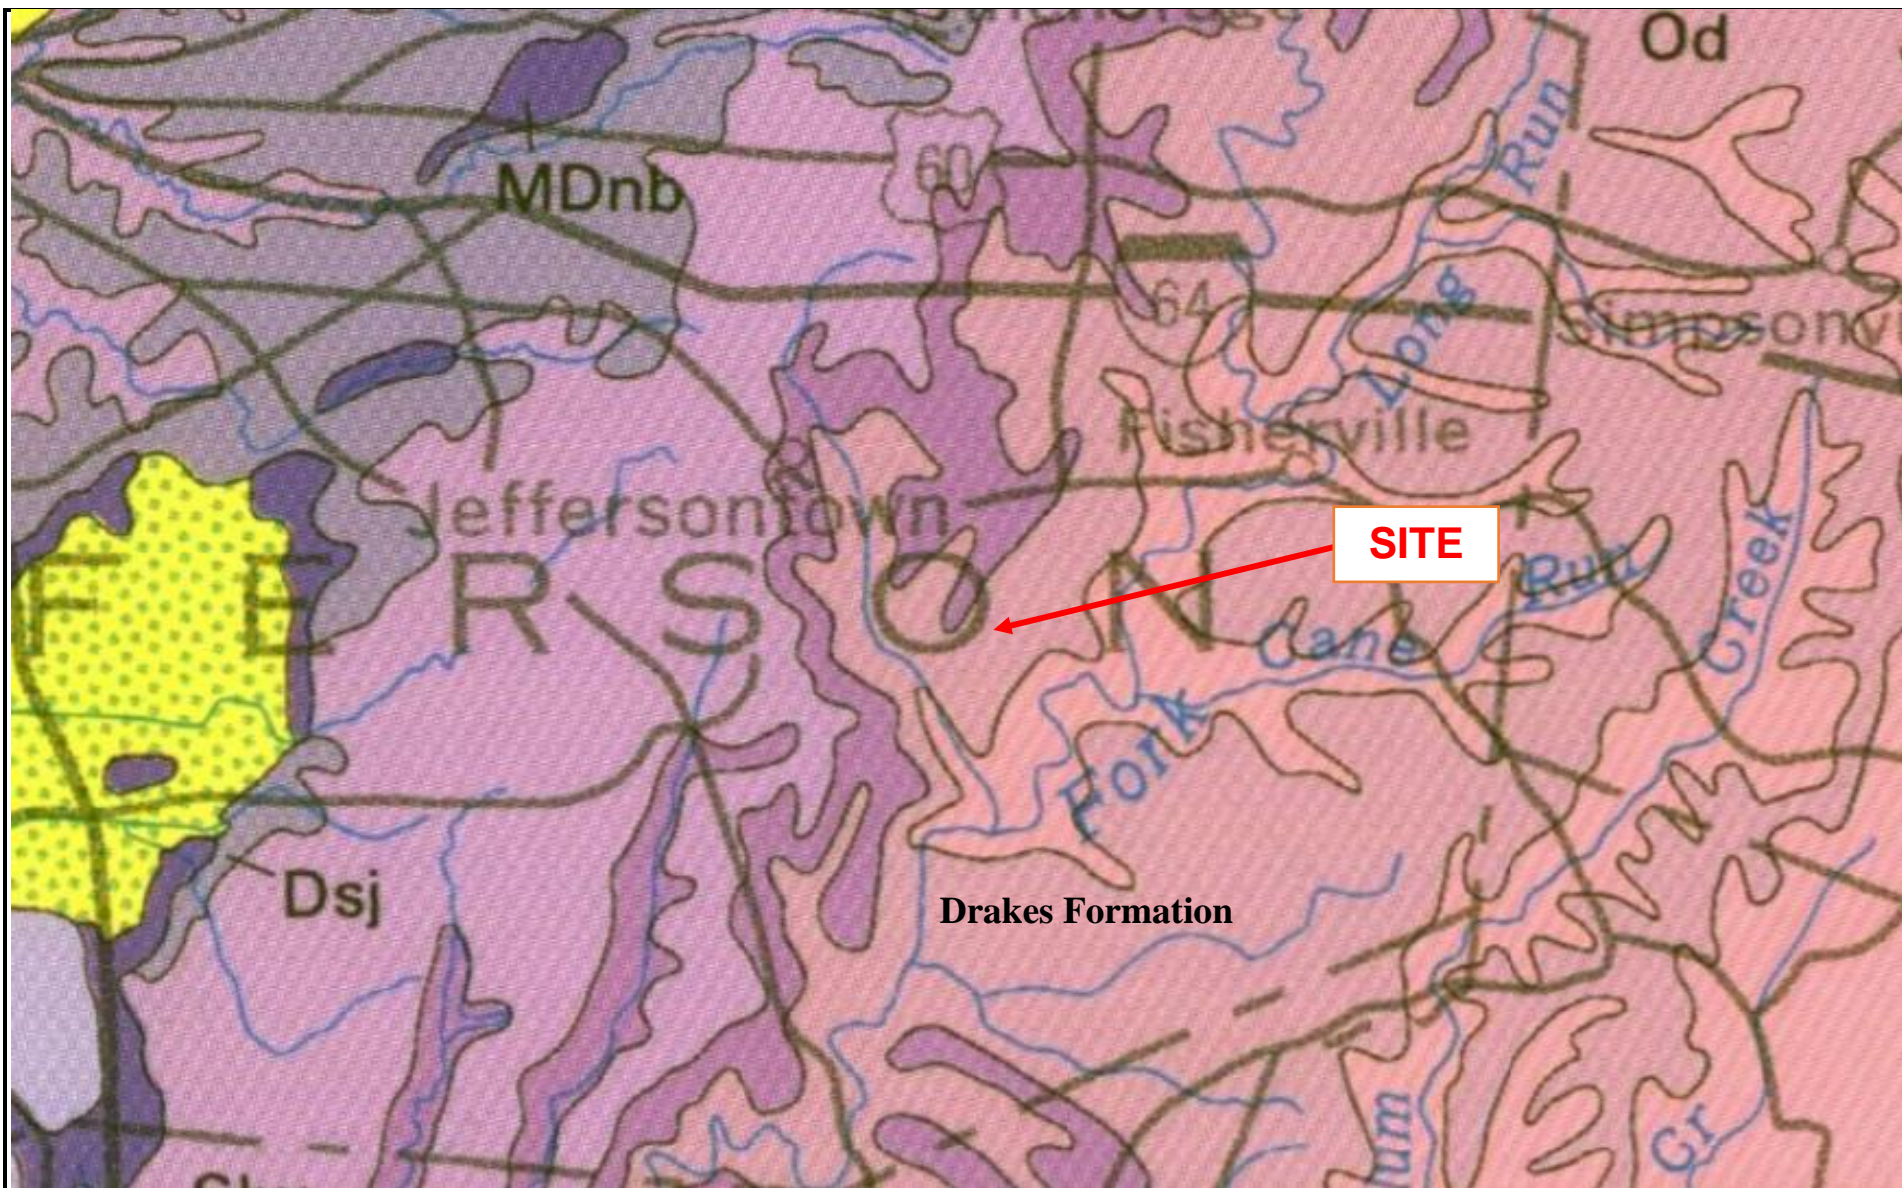
**Site Geology**

This site is shown by the Kentucky Geological Survey to be underlain by the Drake's Formation. The Geological Survey describes the Drakes Formation as:

Grayish green dolomite or limy silty mudstone and lesser amounts of argillaceous, fine-grained dolomite or dolomitic limestone. Megafossils absent or sparse in mudstone, some dolomite beds contain abundant poorly preserved bryozoans or brachiopods. Mudstone contains ripplemarks and mudcracks. 135 ft thick at type section. Divided into Rowland and overlying Preachersville Members. Conformably overlies Ashlock Formation; disconformably overlain by Brassfield Dolomite. Assigned to Late Ordovician. Approximately same rocks called the Waynesville limestone and overlying Liberty and Whitewater formations.
