Reference: **Broad Run Road – Karst Survey**
8000 Broad Run Road
Louisville, Jefferson County, Kentucky 40291
ECS Project No. 61-2612

Attachments: Karst Feature Location Plan(s) – 6 pages
Karst Potential Map (obtained from KGS Geologic Map Information Service website) – 1 page
Site Photos – 33 pages
Karst Feature Remediation Section – 1 page

Karst Feature Location Plan

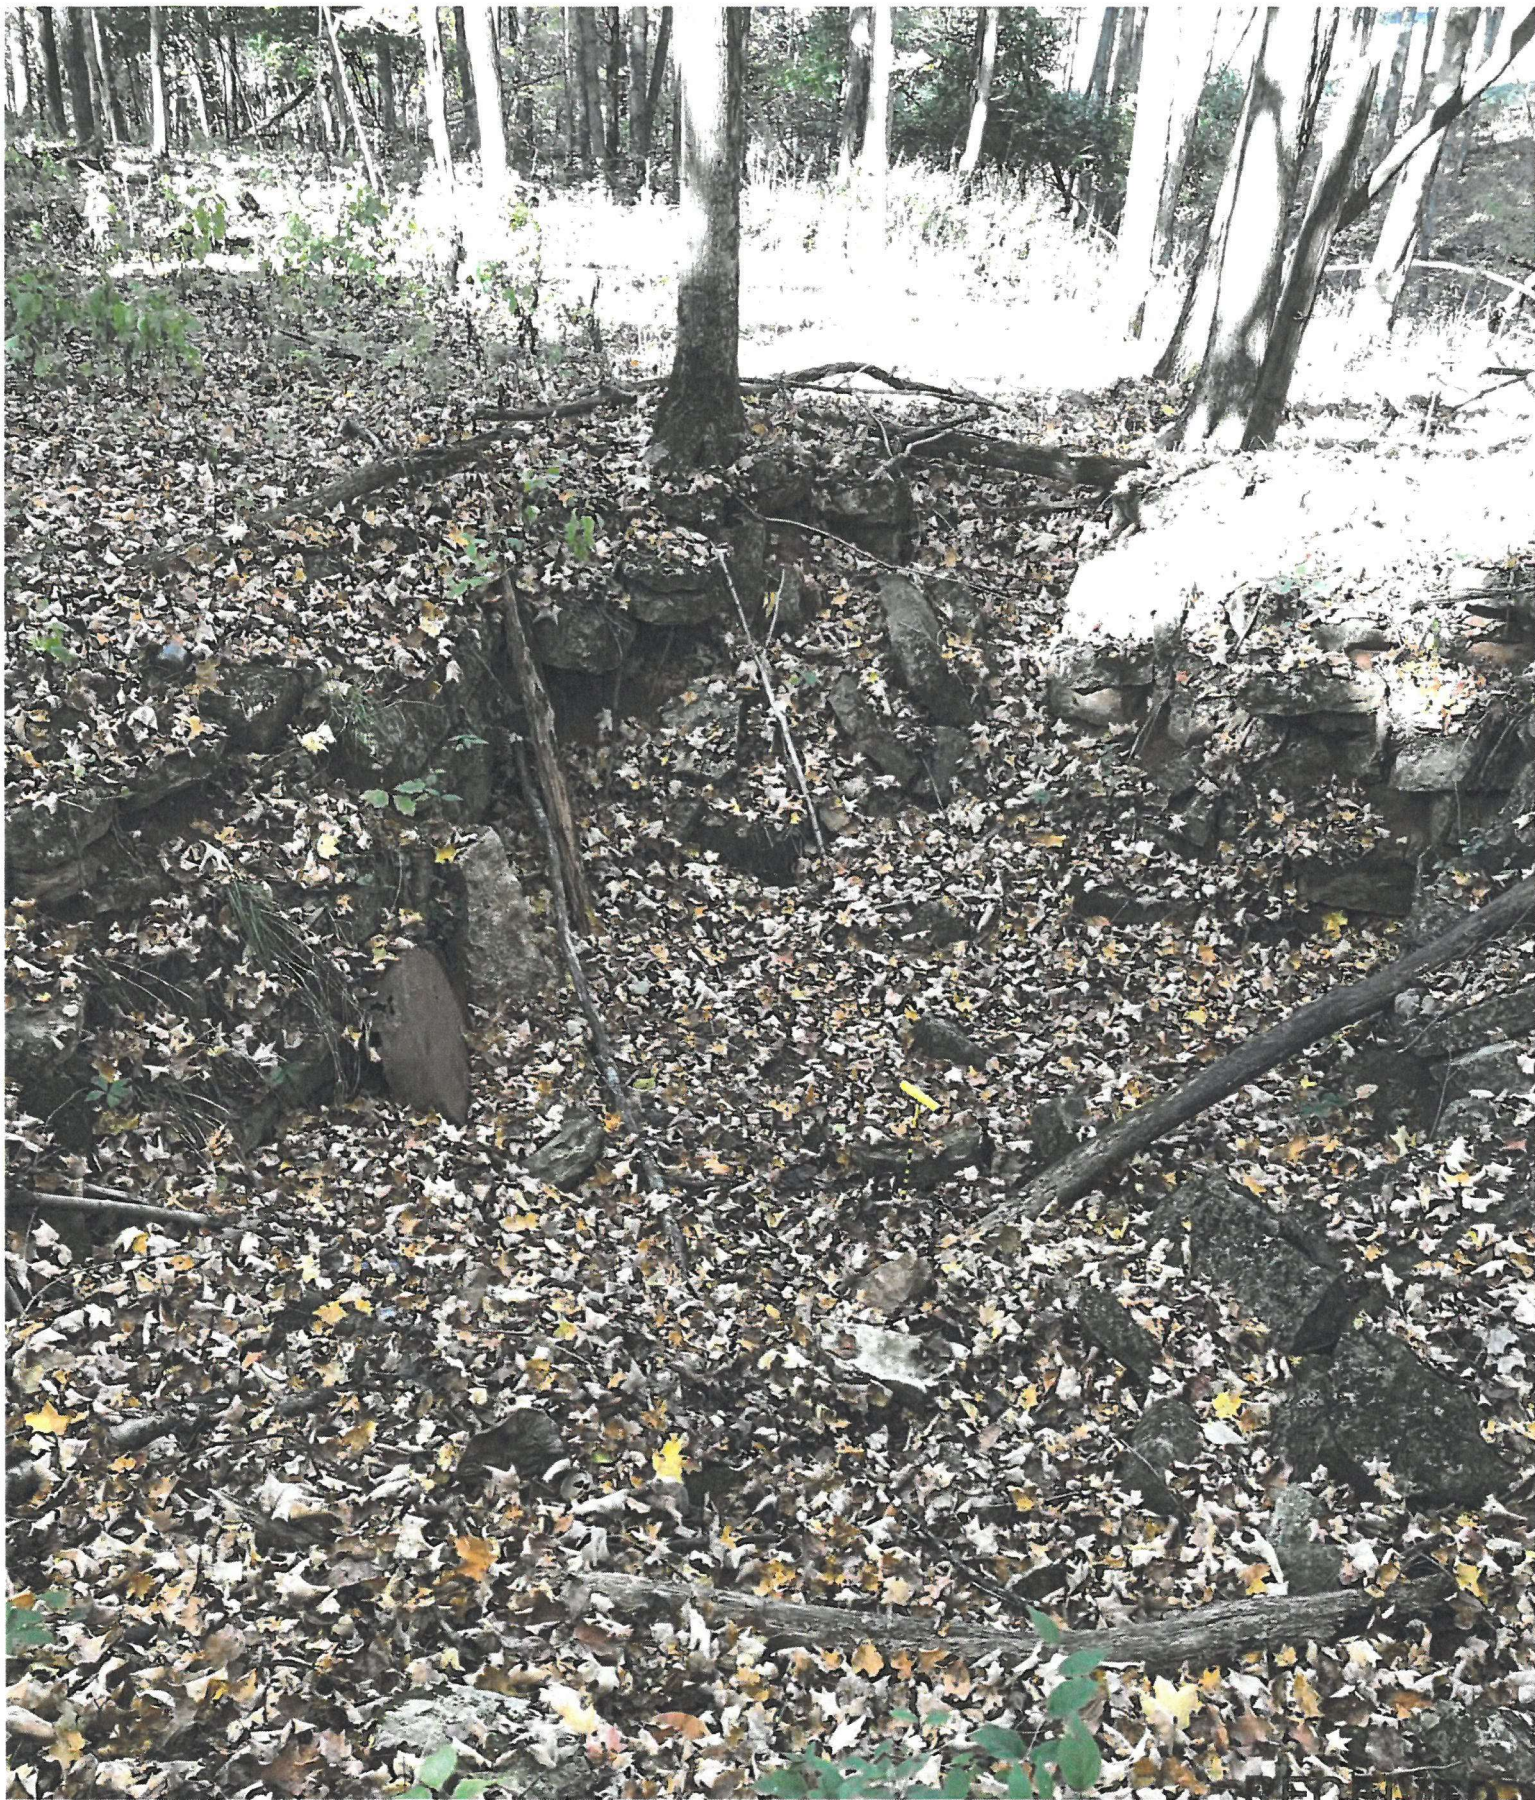
Site Photos (F-01)

Feature	Description	Approximate Dimensions	Approximate Depth
F-1	Trench-shaped depression with soil sidewalls.	2.5' Wide 11' Long	2'
F-2	Closed depression. Evidence of apparent human disturbance with sidewalls lined by limestone blocks.	11' Wide 15' Long	5'
F-3	Closed depression with soil sidewalls.	10' Diameter	4'
F-4	Oval-shaped closed depression with soil sidewalls.	4' Wide 9' Long	3'
F-5	Oval-shaped closed depression with soil sidewalls.	7' Wide 17' Long	4'
F-6	Closed depression with soil sidewall and a partially closed throat encountered at the bottom of the depression.	7' Diameter	4'

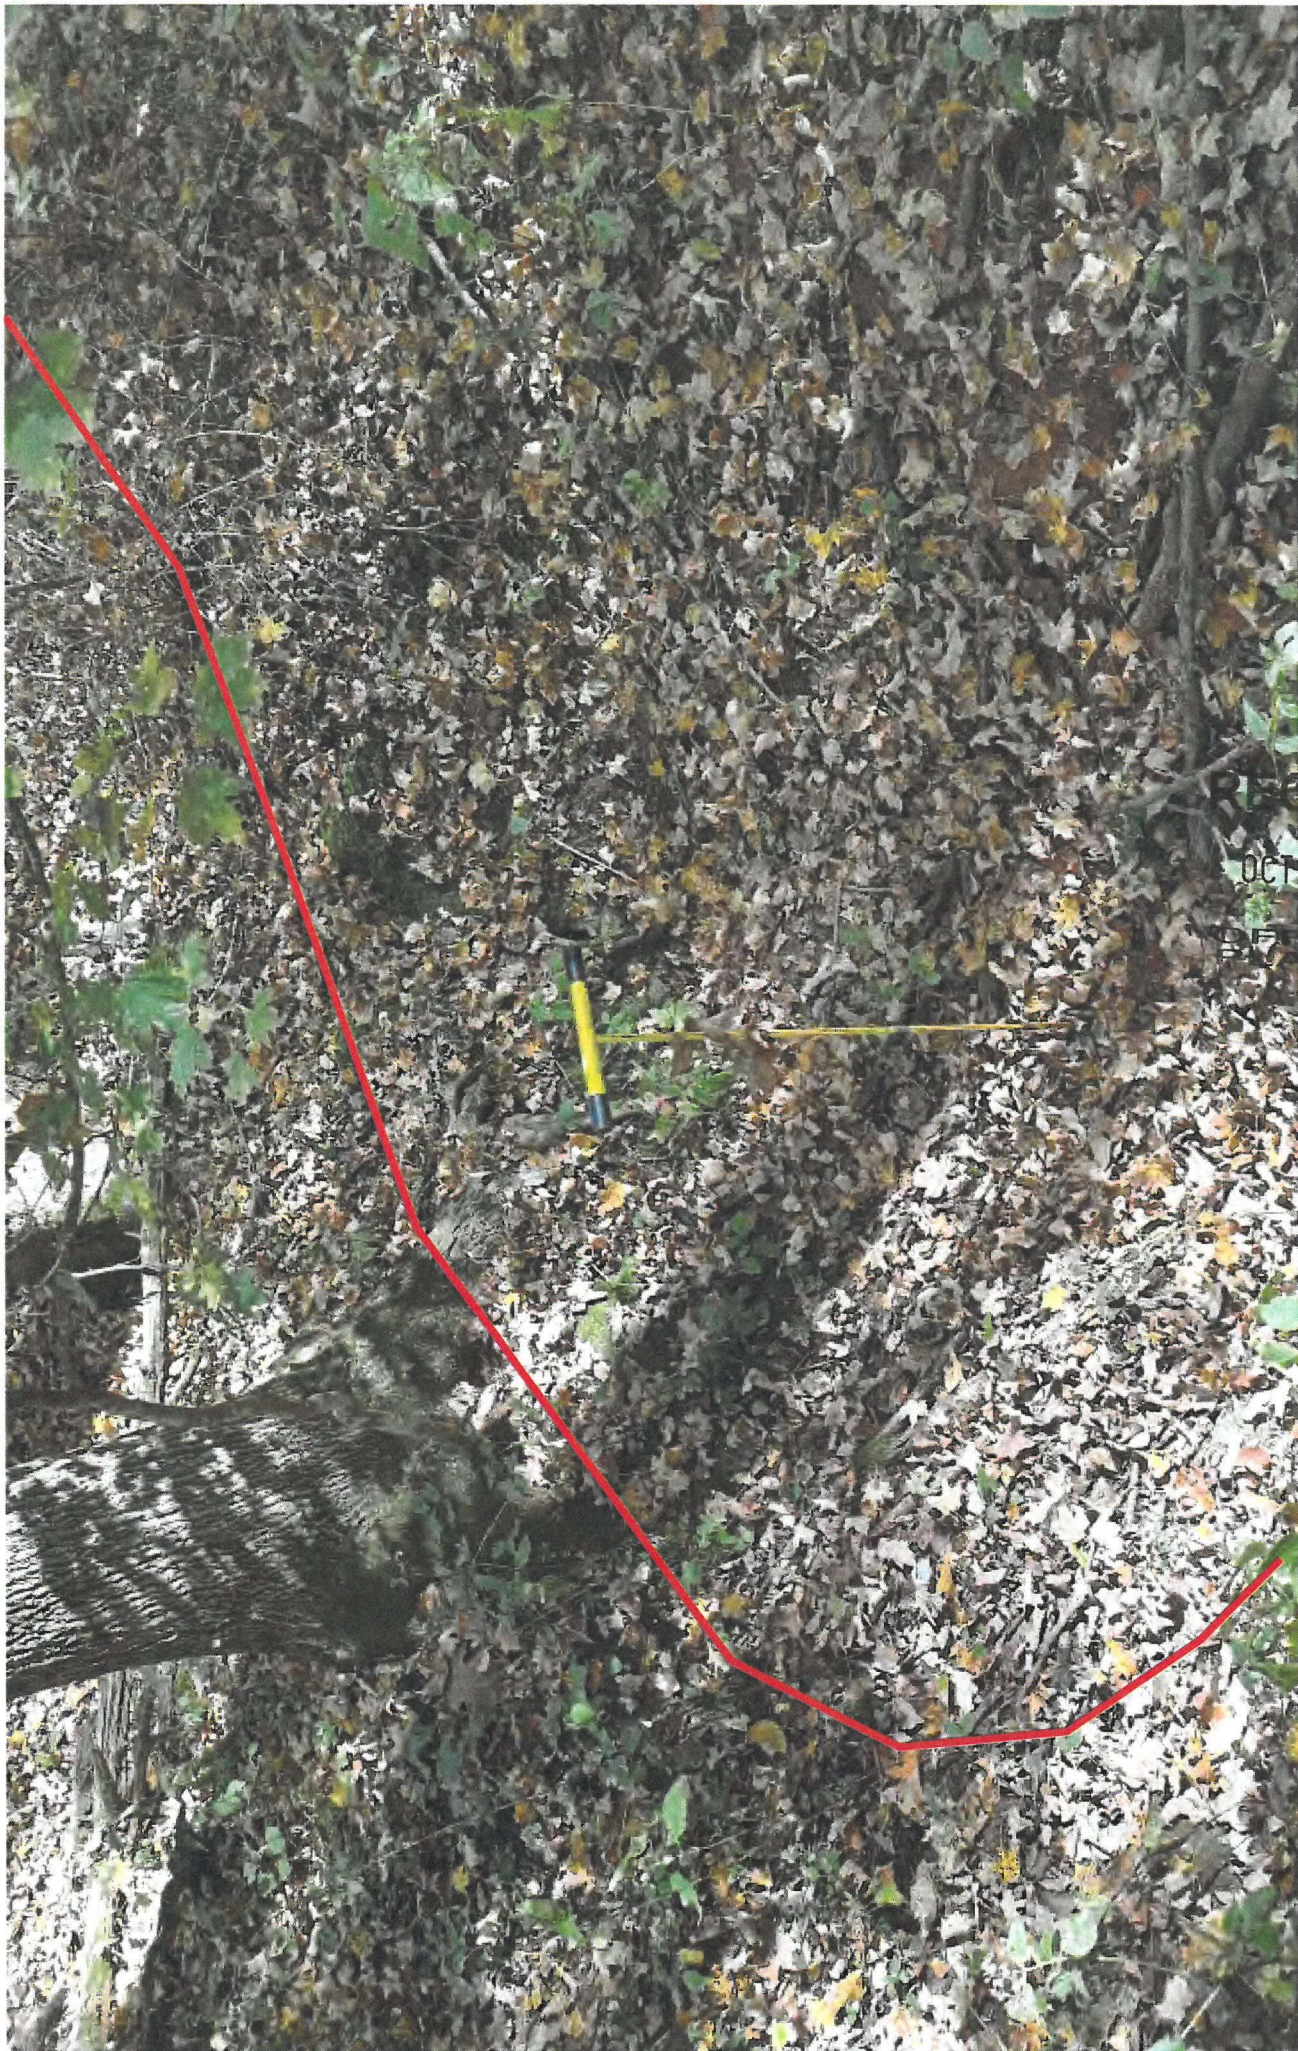
Site Photos (F-16)
Broad Run Road – Karst Survey
8000 Broad Run Road, Louisville, Kentucky 40291
ECS Project No.: 61-2612

F-16	Closed depression with soil sidewalls.	20' Diameter	8'
F-17	Closed depression with soil sidewalls.	6' Diameter	4'

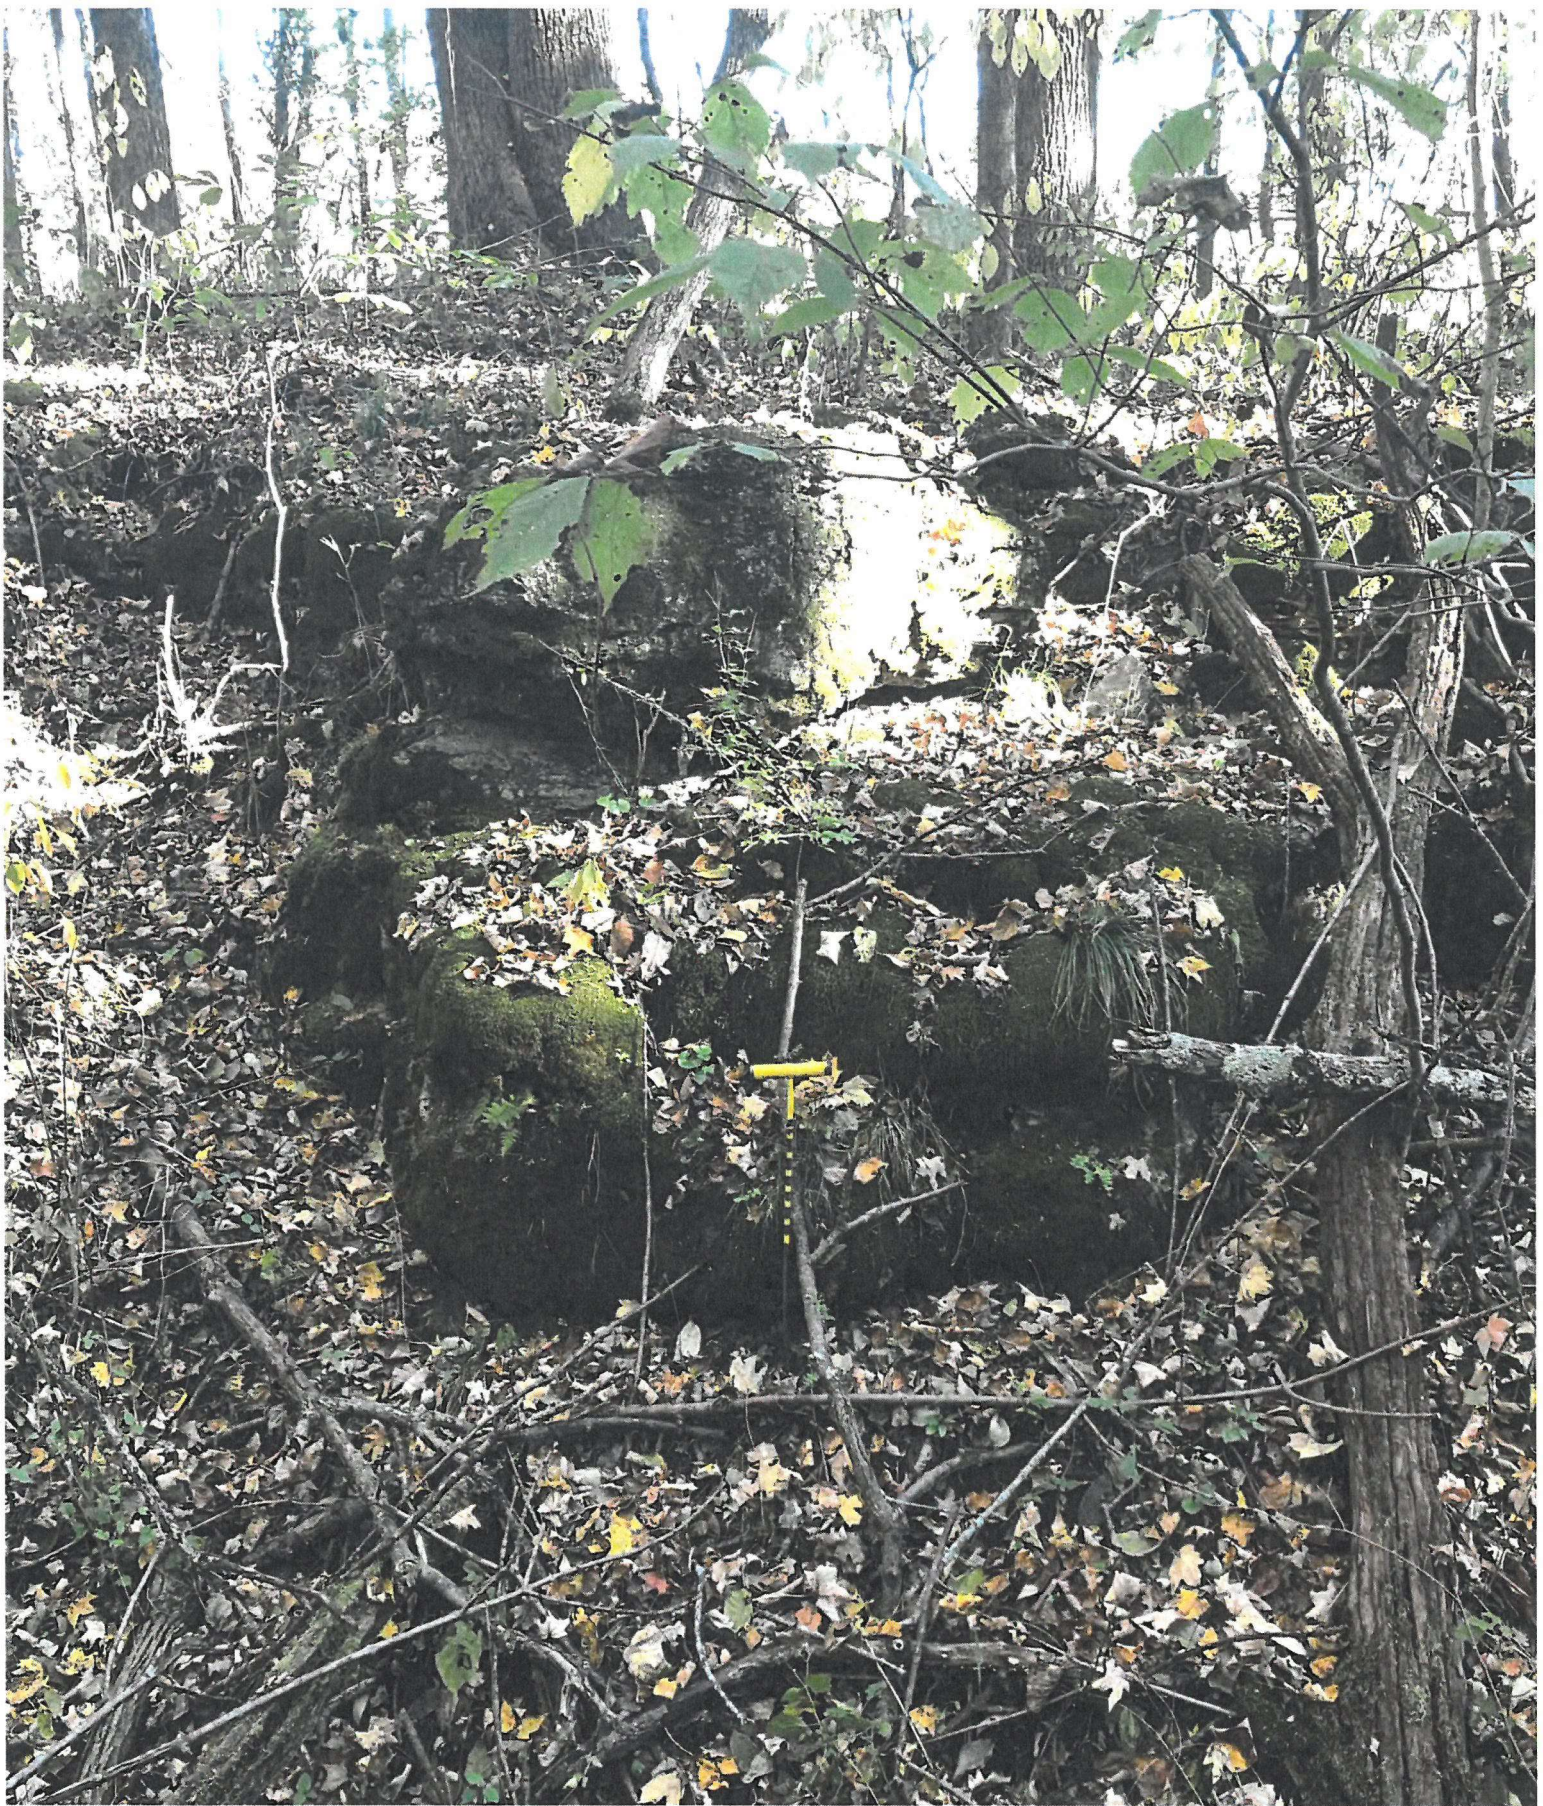
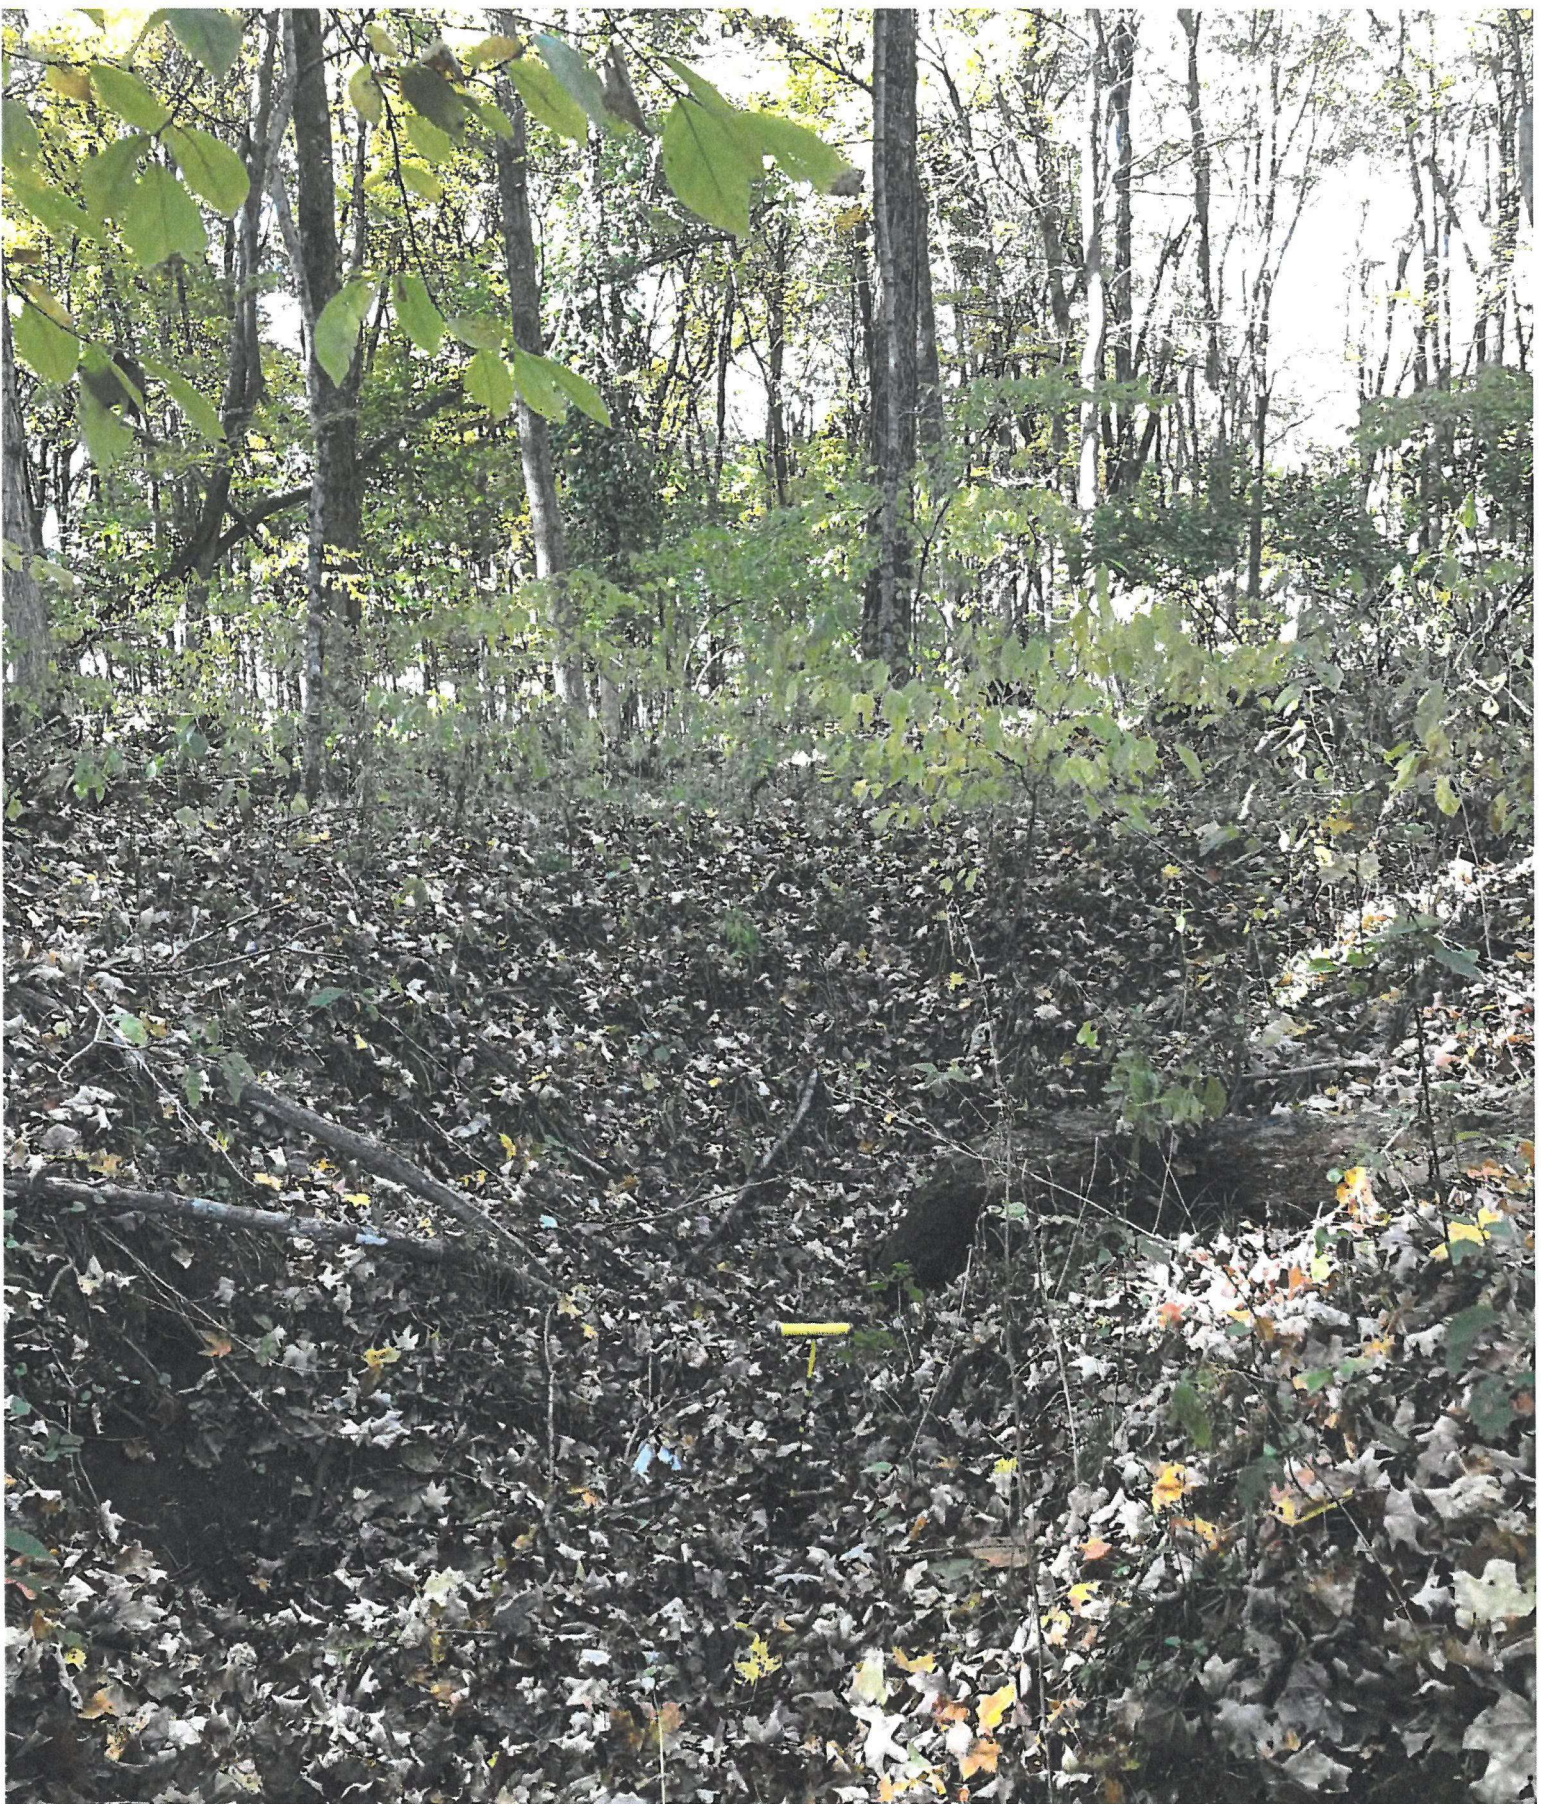
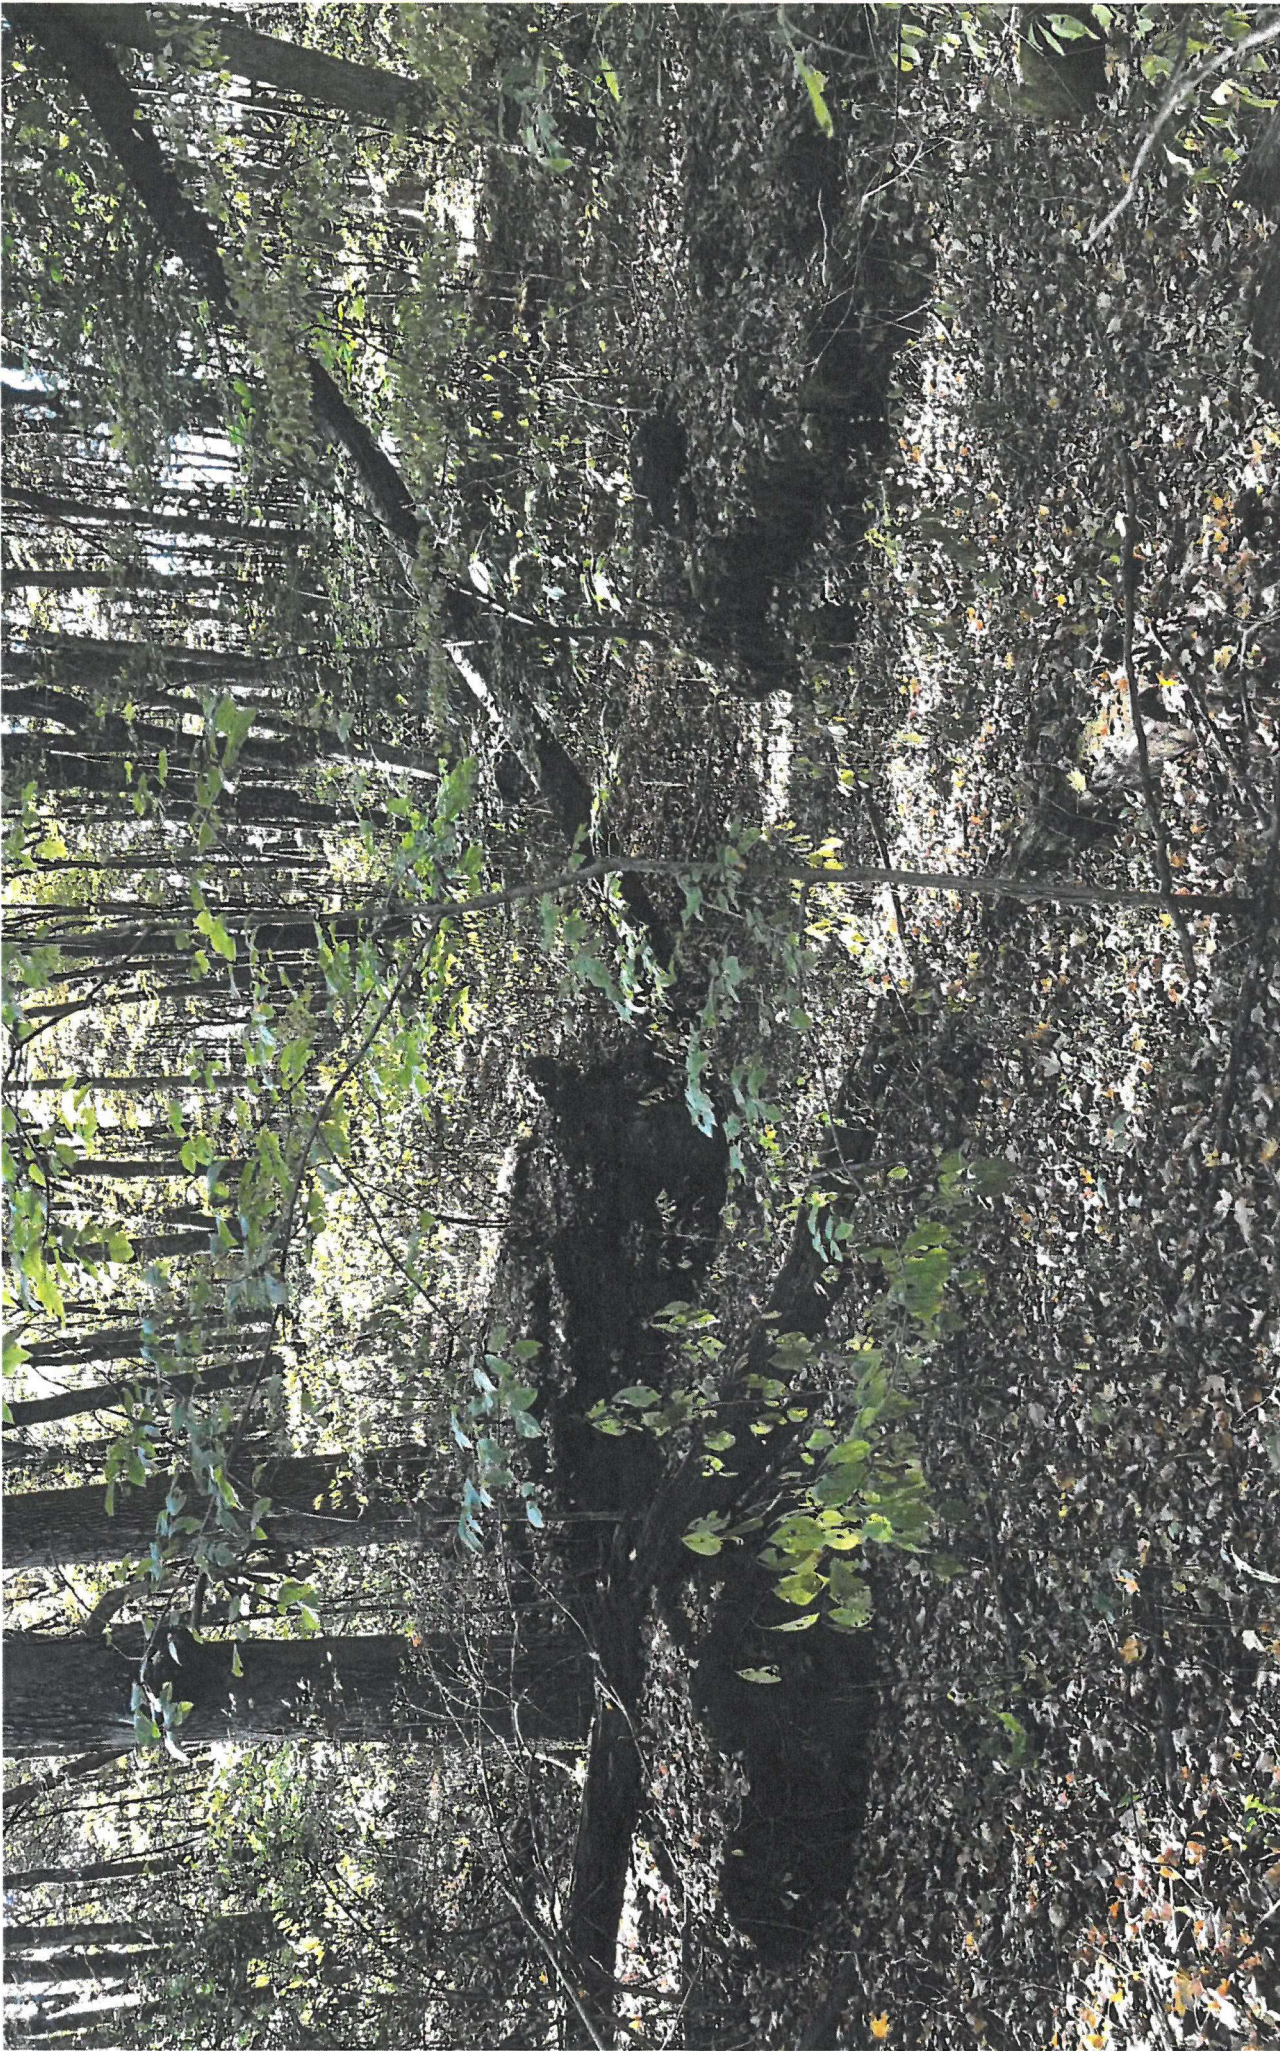
Site Photos (F-70)
Broad Run Road – Karst Survey
8000 Broad Run Road, Louisville, Kentucky 40291
ECS Project No.: 61-2612

D	Small opening with apparent rock sidewalls.	1' Diameter	> 4'
F-70	Large, closed depression with soil/rock sidewall that contained slot-shaped features, closed depressions, and several small openings.		40' Wide 70' Long	15'
	A	Slot-shaped feature with soil/rock sidewalls.	5' Wide 13' Long	5'
	B	Slot-shaped feature with soil/rock sidewalls.	5' Wide 40' Long	3'
	C	Several small openings with soil/rock sidewalls. Probe rod extended greater than 4 feet below the bottom of the feature.	9" Diameter	> 4'
F-71	Large, closed depression with soil/rock sidewalls that contains a smaller closed depression (approximately 6 feet in diameter and 1 foot deep) encountered at the bottom of the feature.		22' Wide 120' Long	8'
F-72	Shallow closed depression with soil sidewalls.		5' Diameter	0.5'
F-73	Closed depression with soil sidewalls and a partially closed throat encountered at the bottom of the depression.		5' Diameter	2.5'

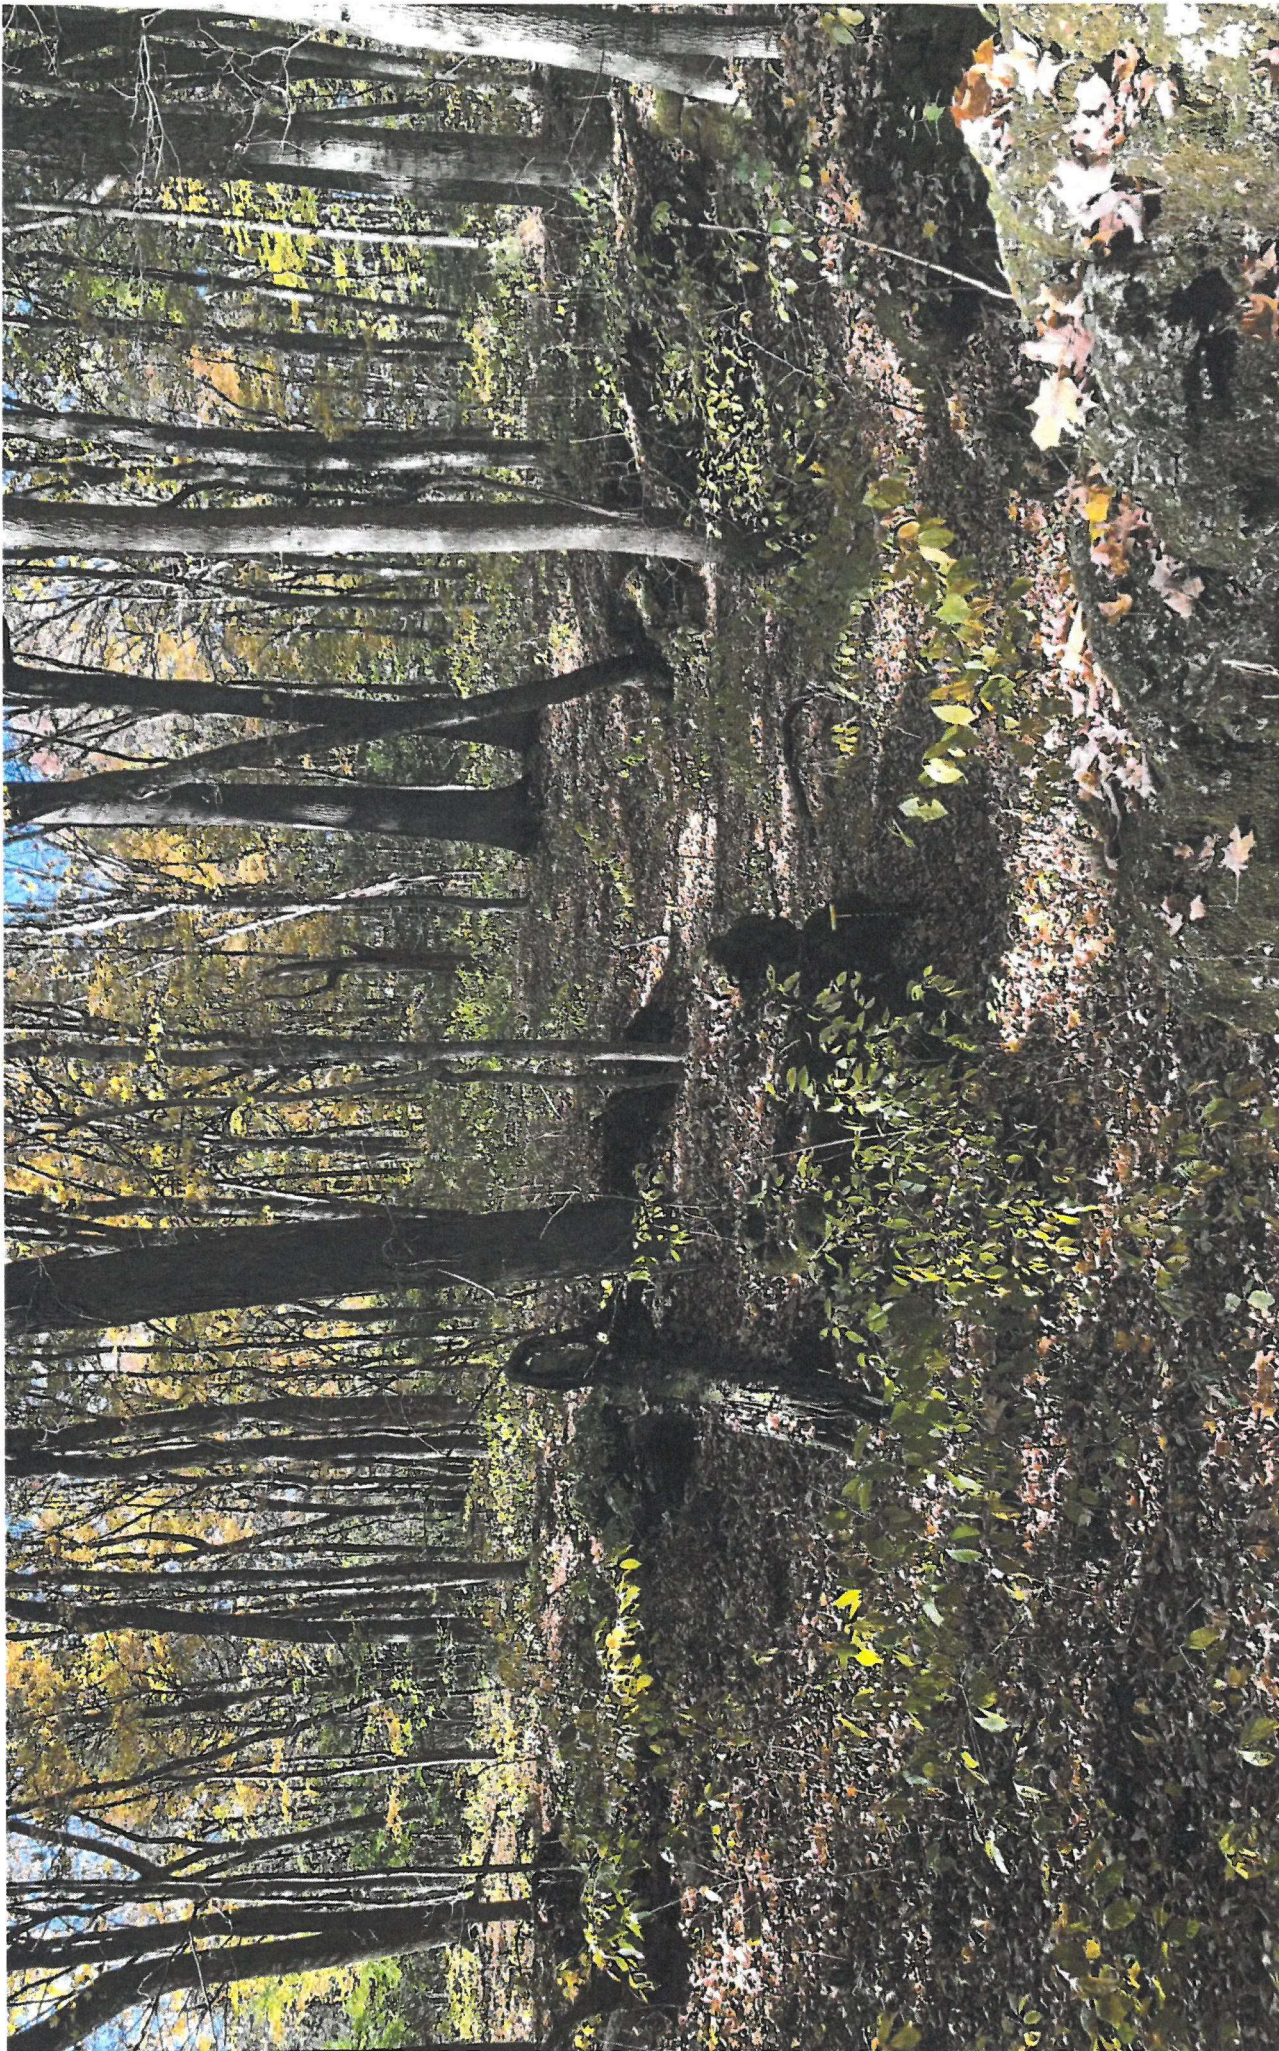
Site Photos (F-77)

Feature	Description	Approximate Dimensions	Approximate Depth
F-76	Closed depression with soil sidewalls.	5' Diameter	2'
F-77	Closed depression with soil/rock sidewalls.	20' Wide 35' Long	3'
F-78	Closed depression with soil sidewalls.	11' Diameter	3'
F-79	Large, closed depression with soil/rock sidewalls that contains a small opening (approximately 3 inches) encountered at the bottom of the feature. Probe rod extended greater than 4 feet below the feature.	12' Wide 20' Long	5'
F-80	Closed depression with soil sidewalls.	7' Diameter	1'
F-81	Closed depression with soil sidewalls.	7' Diameter	2'
F-82	Large, closed depression with soil/rock sidewalls that contains two (2) smaller closed depressions (approximately 3-6 feet in diameter and 0.5-2 feet deep) encountered at the bottom of the feature.	20' Wide 30' Long	2-4'
F-83	Large, closed depression with soil/rock sidewalls that contains two (2) smaller closed depressions (approximately 5-8 feet in diameter and 3 feet deep) encountered at the bottom of the feature.	13' Wide 33' Long	3-6'

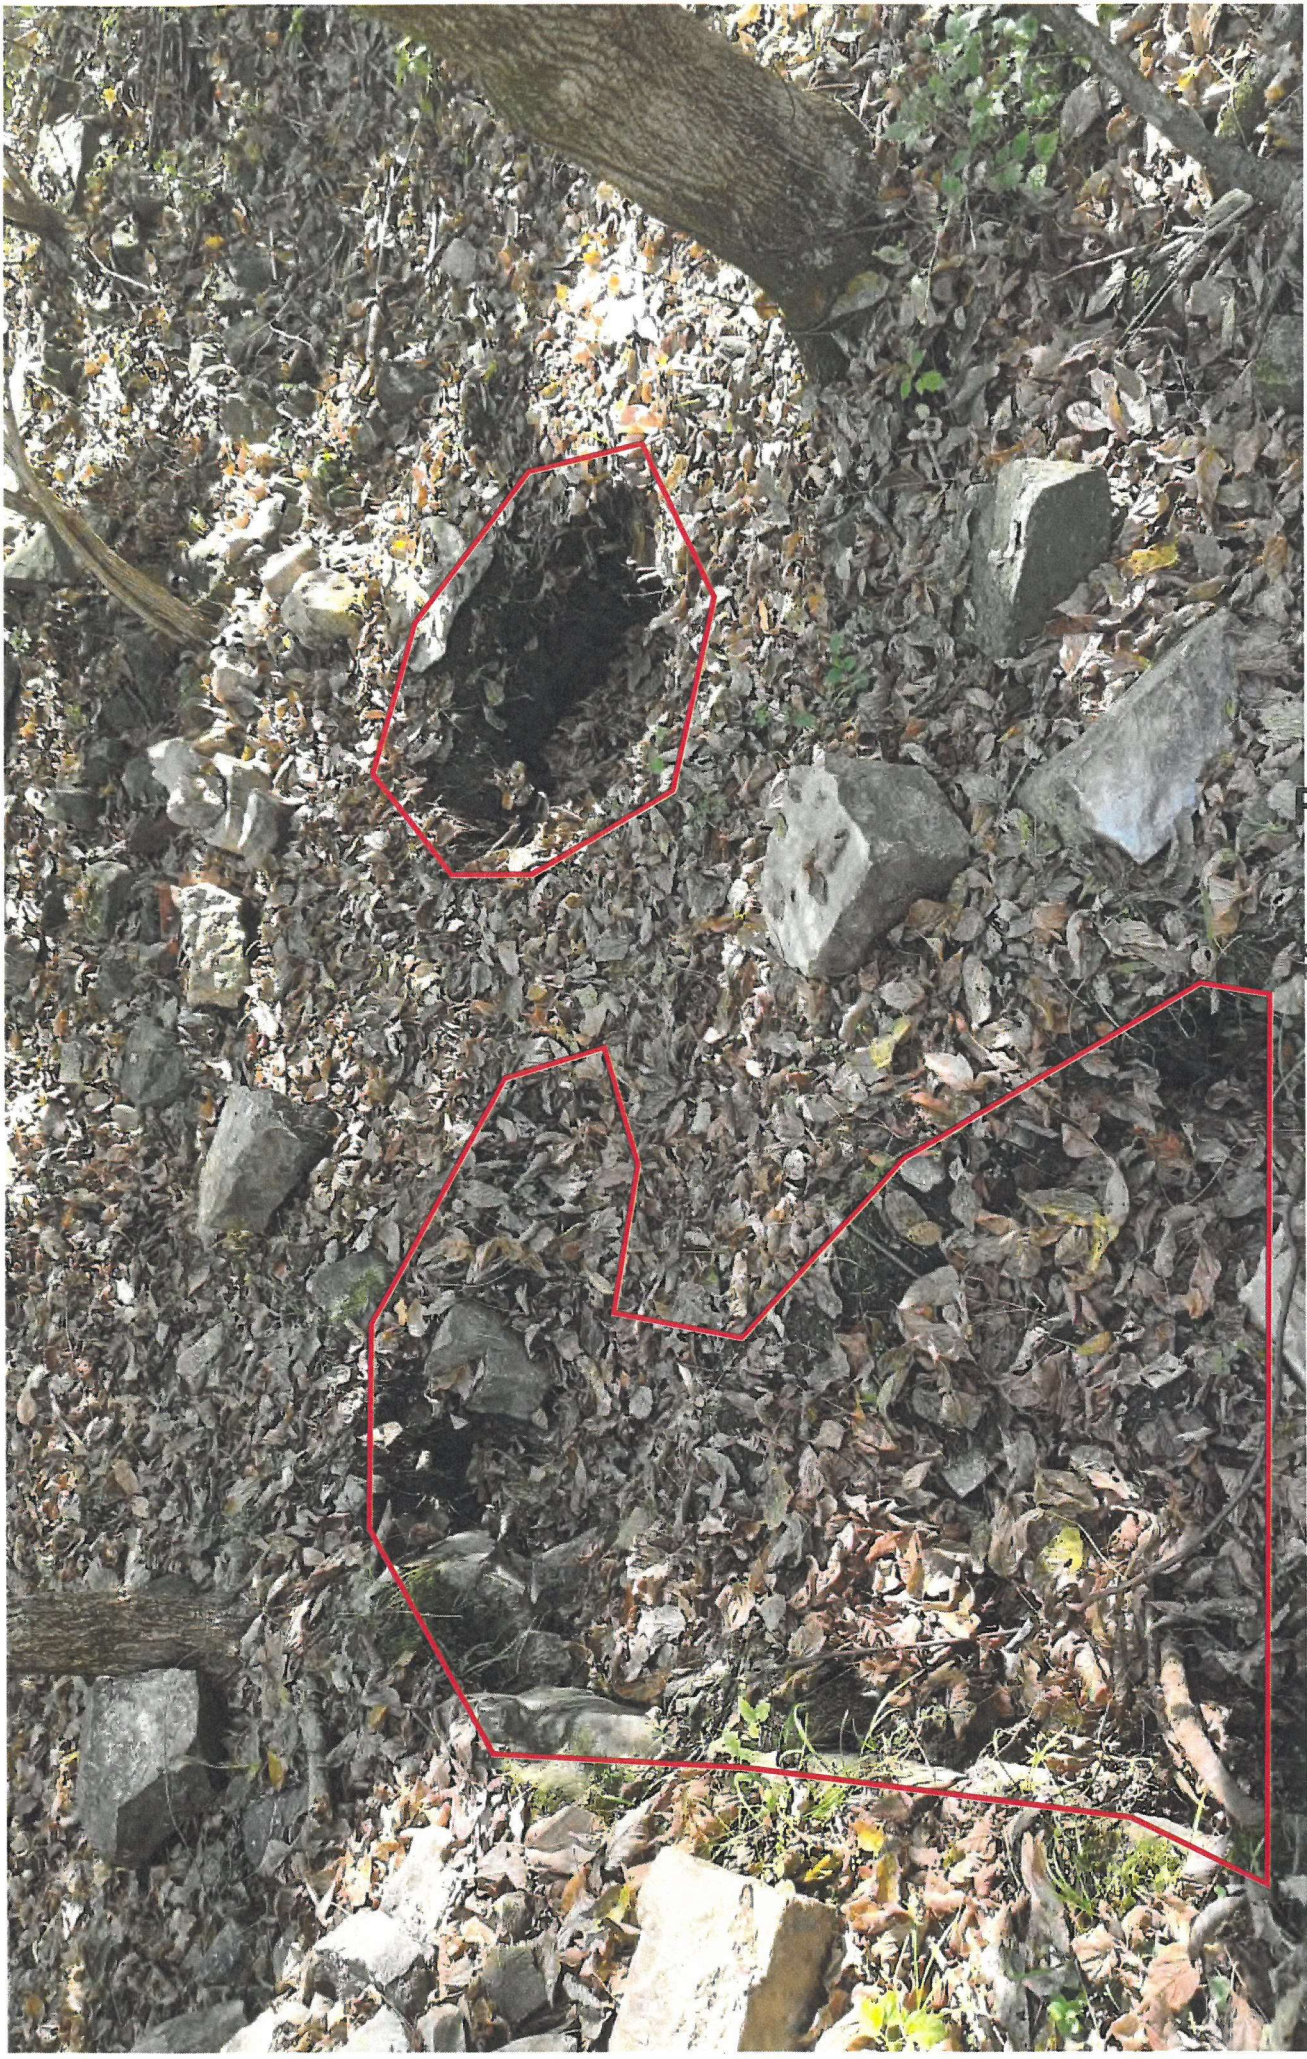
Site Photos (F-97)

F-97	Slot-shaped feature with apparent rock sidewalls. Bottom of feature inaccessible due to steep slopes.	4' Wide 20' Long	11'
F-98	Large, closed depression with soil/rock sidewalls that contains a slot-shaped feature (approximately 7 feet wide, 48 feet long, and 6 feet deep) encountered at the bottom of the feature.	30' Wide 70' Long	6-8'
F-99	Closed depression with soil sidewalls.	6' Diameter	4'
F-100	Large, closed depression with soil/rock sidewalls that was partially filled with debris.	50' Diameter	7'
F-101	Large, closed depression with soil/rock sidewalls that contains two (2) closed depressions within the feature.	70' Diameter	7'
	A Closed depression with soil/rock sidewalls.	13' Diameter	4'
	B Slot-shaped feature with soil sidewalls.	25' Long x 4' Wide	1'
F-102	Closed depression with soil sidewalls and a partially closed throat encountered at the bottom of the depression.	2' Diameter	4'

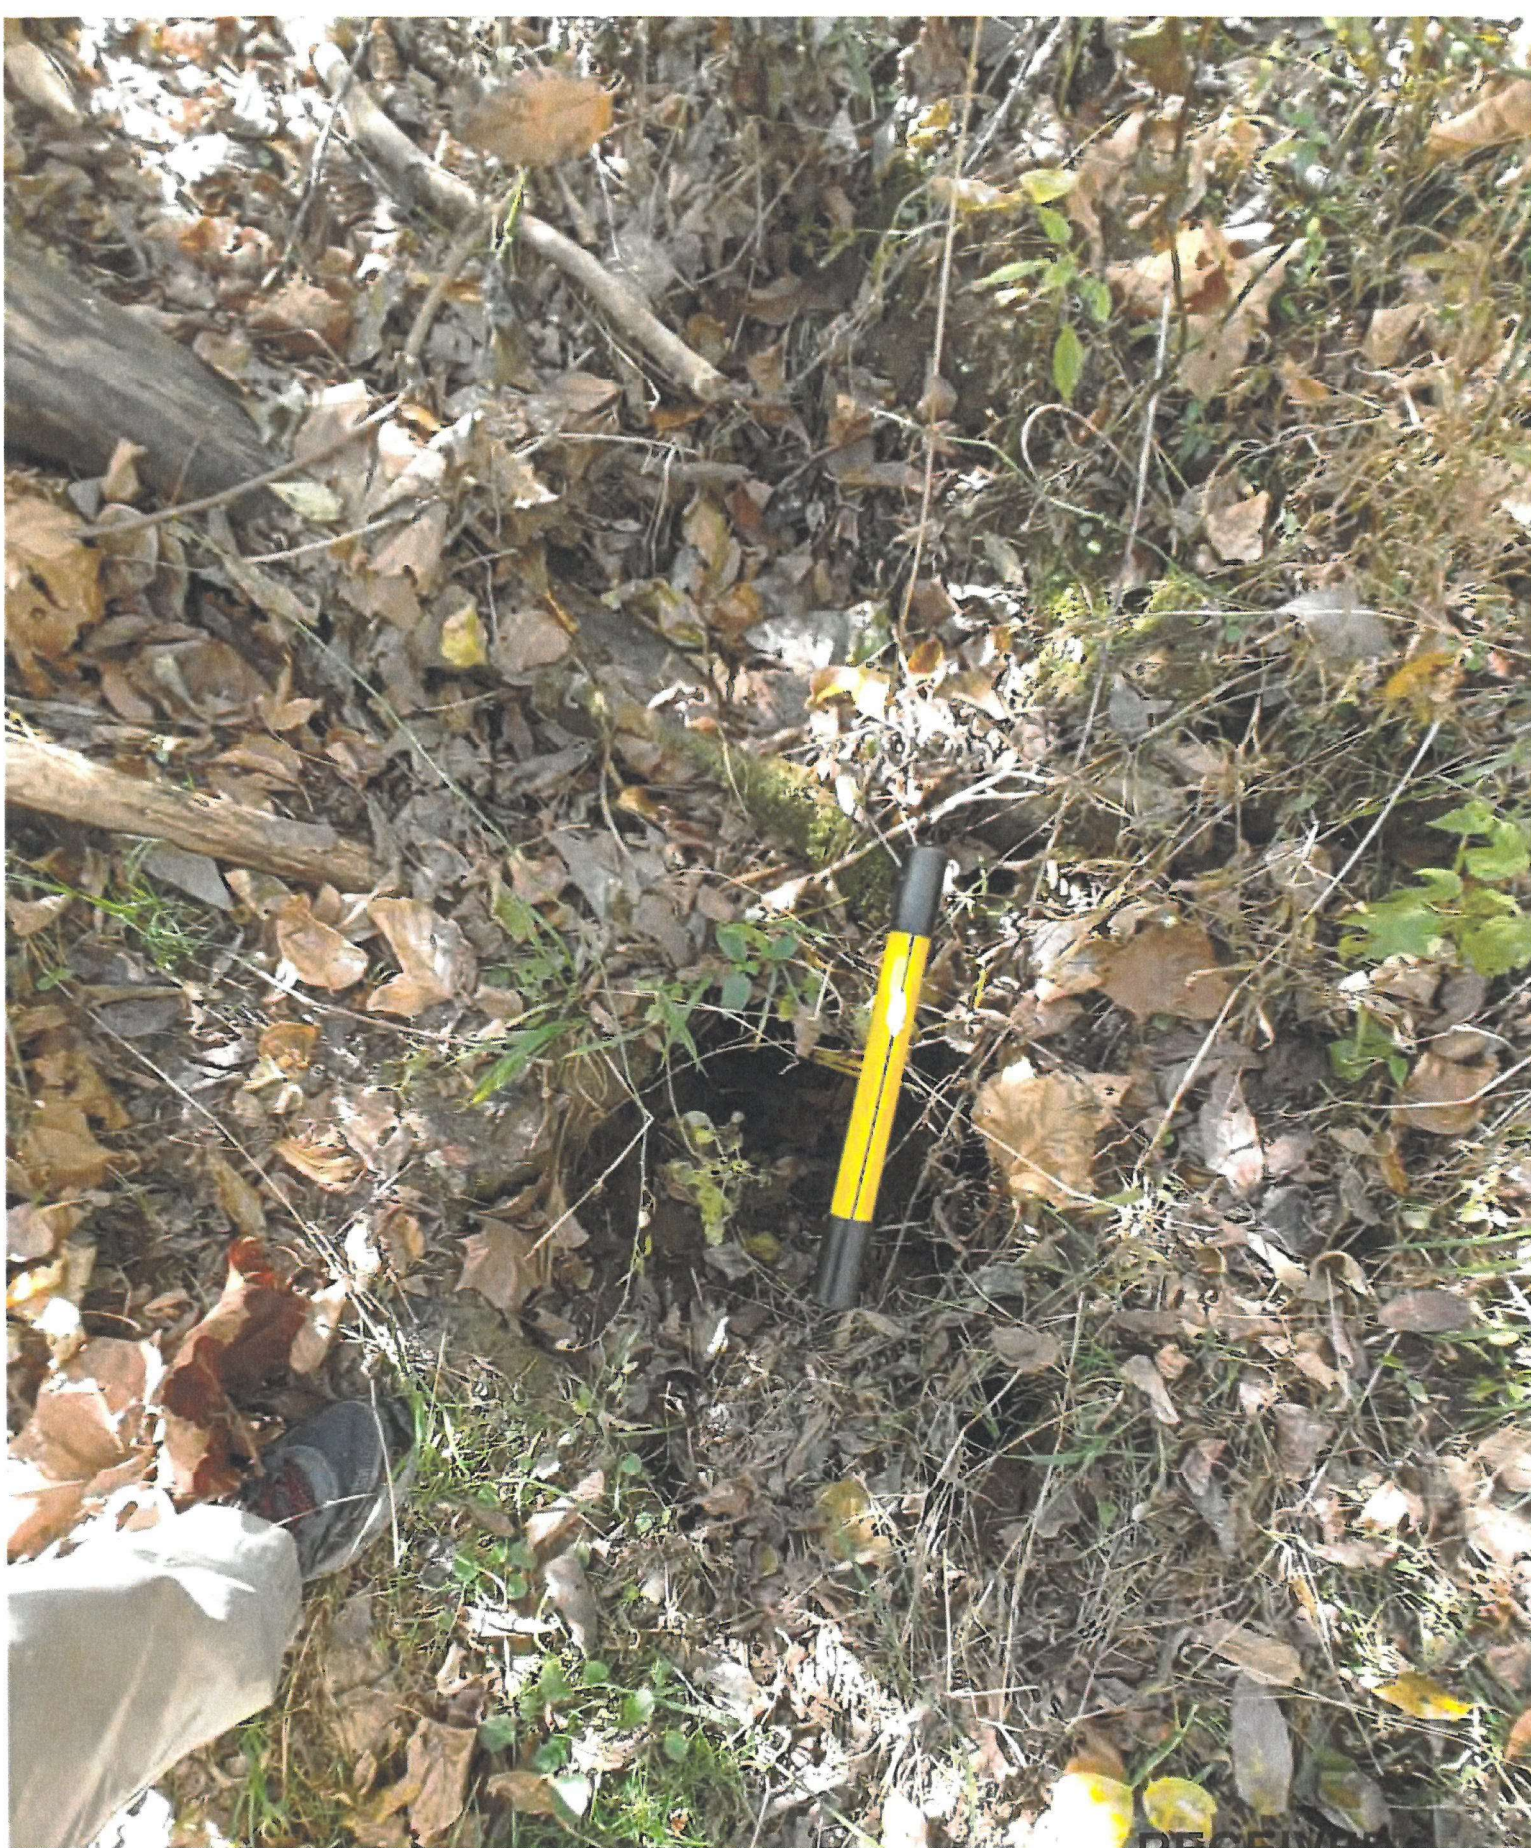
Site Photos (F-103)

F-103	Closed depression with soil sidewalls and a partially closed throat encountered at the bottom of the depression.	8' Diameter	5'
F-104	Closed depression with soil sidewalls.	6' Diameter	4'
