Geotechnical Engineering Report

**Prospect Cove Multi-Family
Louisville, Jefferson County, Kentucky**

Terracon Project No. 57225022

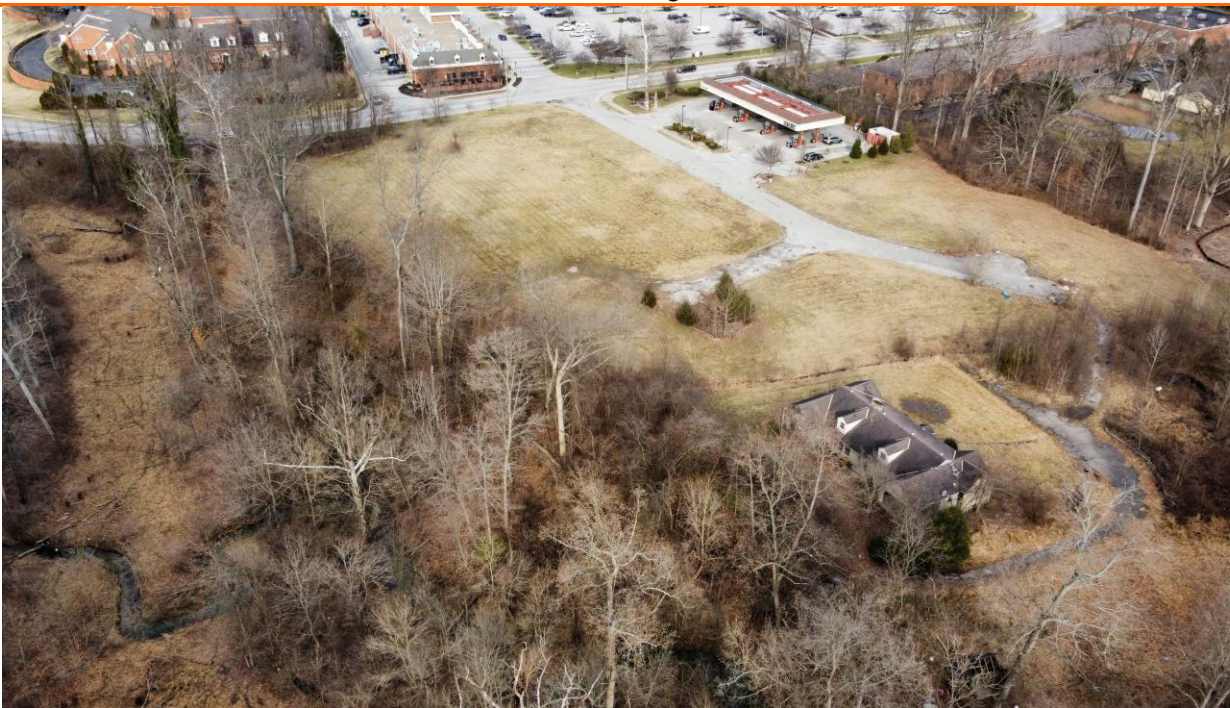
Photo 2. Site Looking Northeast Toward Slope at West Perimeter of Proposed Pavement

The proposed site development and grading include a retaining wall in the vicinity of the existing steep slope to facilitate and increase stability for the proposed development. As construction plans are developed, Terracon recommends geotechnical exploration of the proposed retaining wall area to perform slope stability analyses and provide geotechnical recommendations for retaining wall design and construction for stability for the proposed pavement and building foundations.

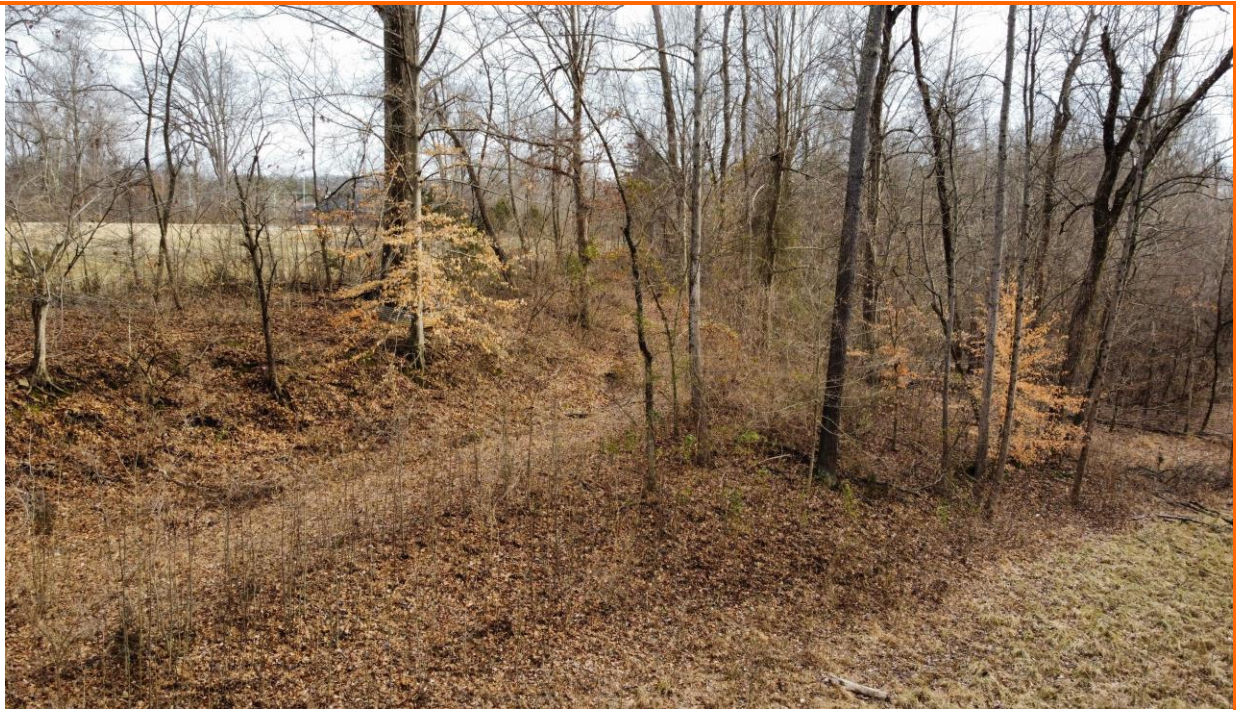
Photo 3. Site Looking Northeast Toward Existing Access Road on Slope

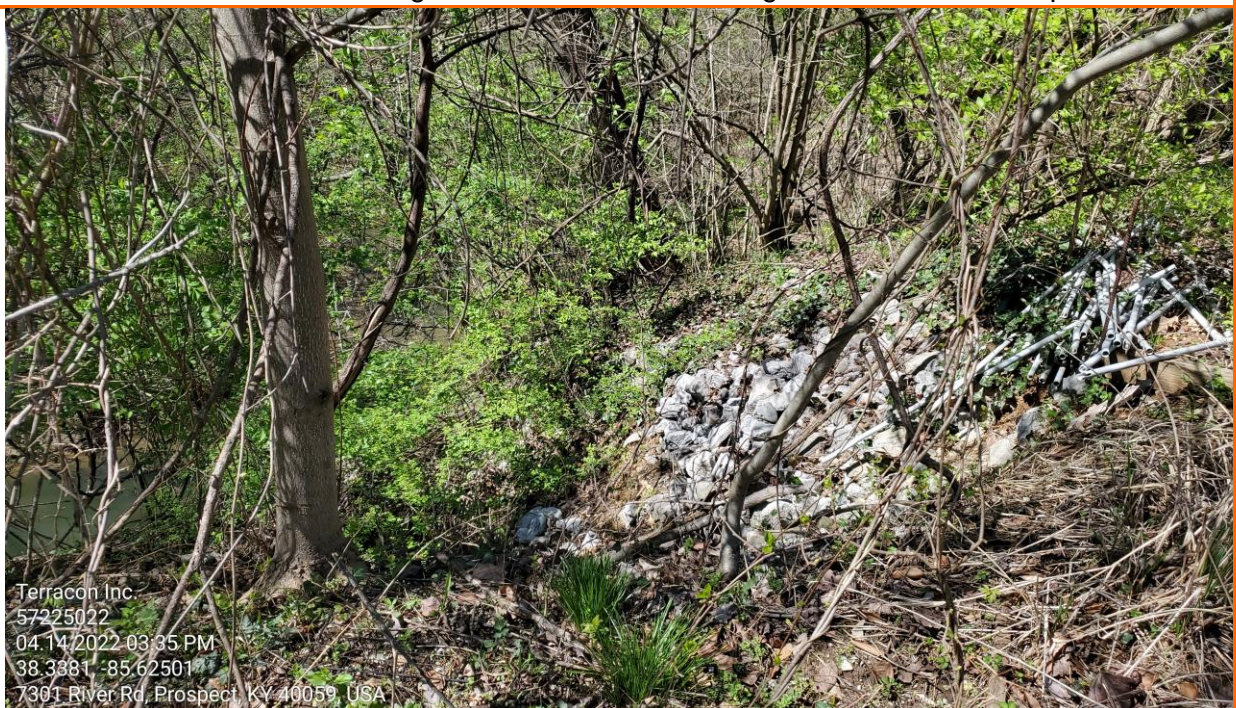
Photo 4. Site Looking Northwest Toward Slope at West of Proposed Pavement

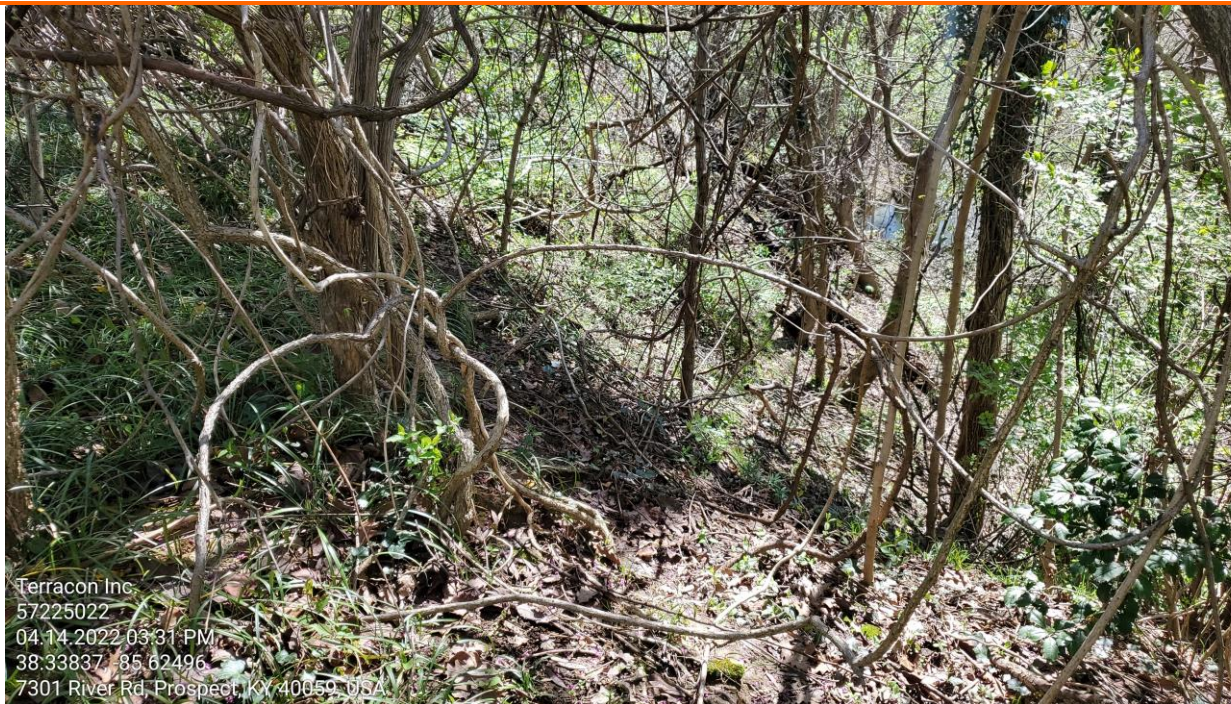
Photo 5. Site Looking Southwest Toward Slope at West of Proposed Pavement

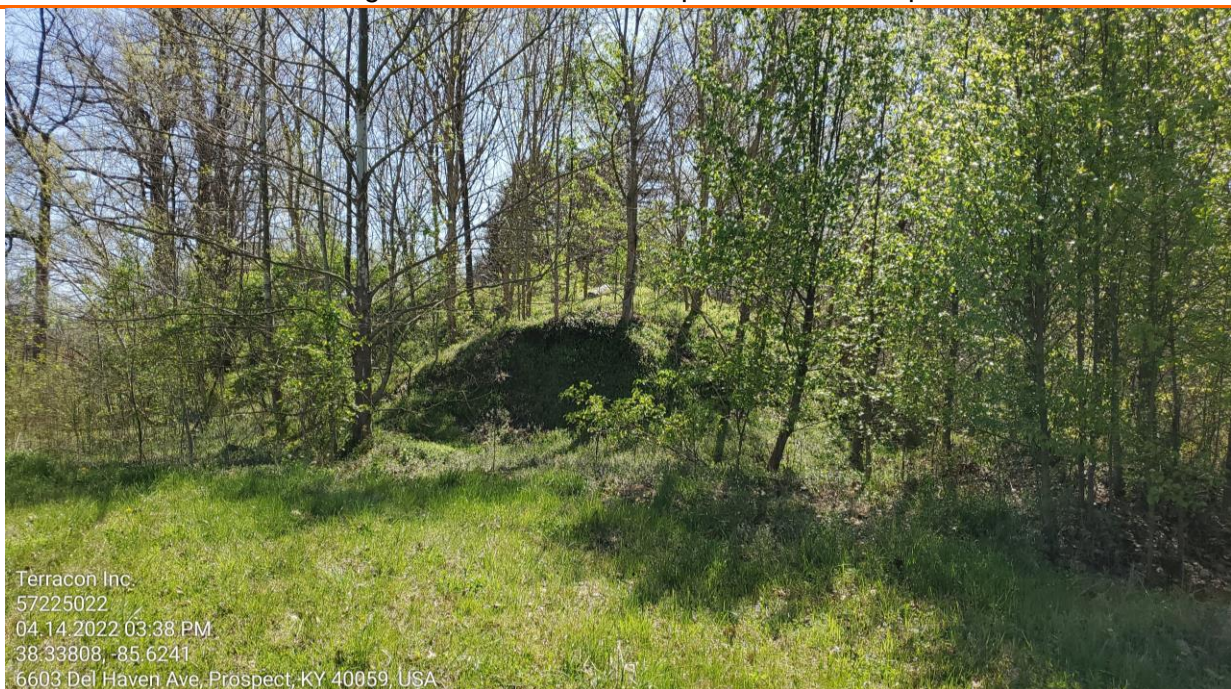
Photo 6. Site Looking South Toward Slope within the Planned Development

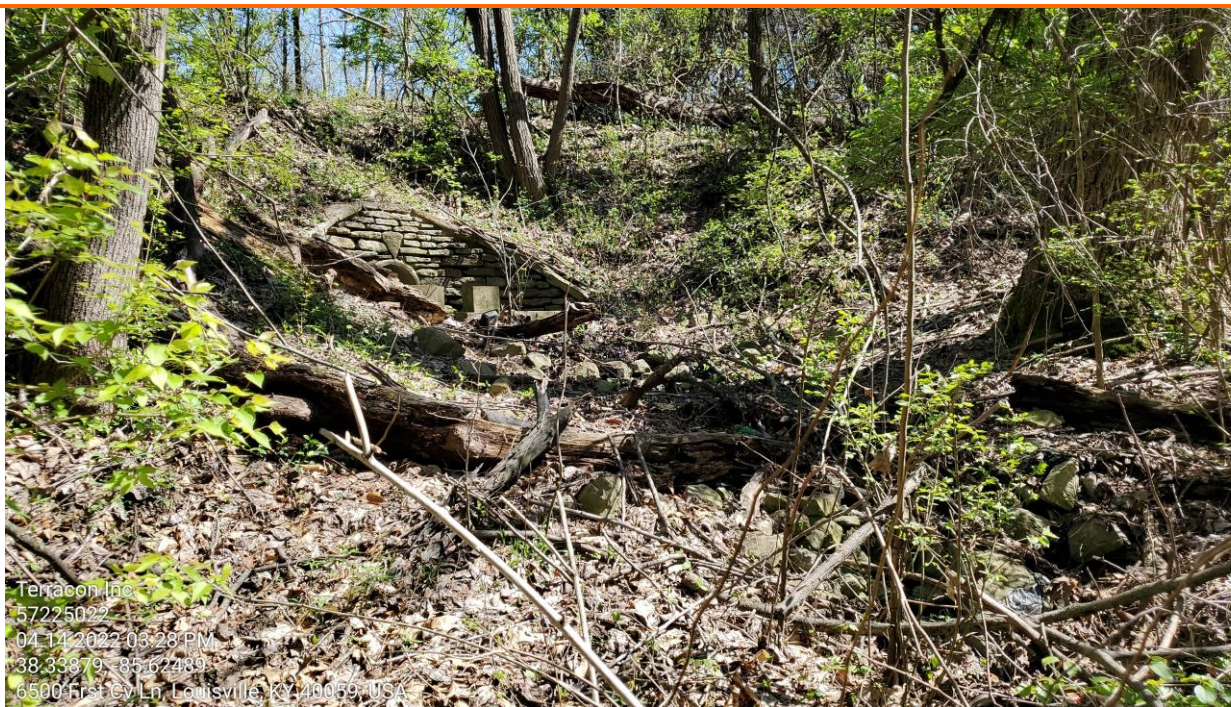
Photo 7. Site Looking Southeast Toward Culvert Headwall Structure at West

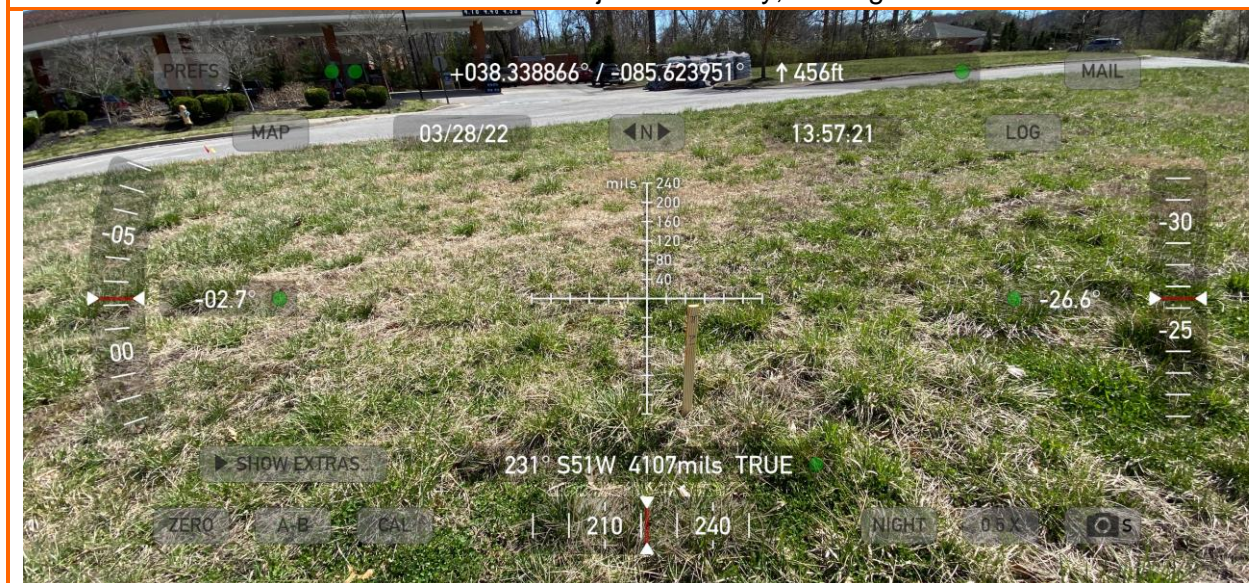
Photo 12: CPT Sounding B-1, looking southeast

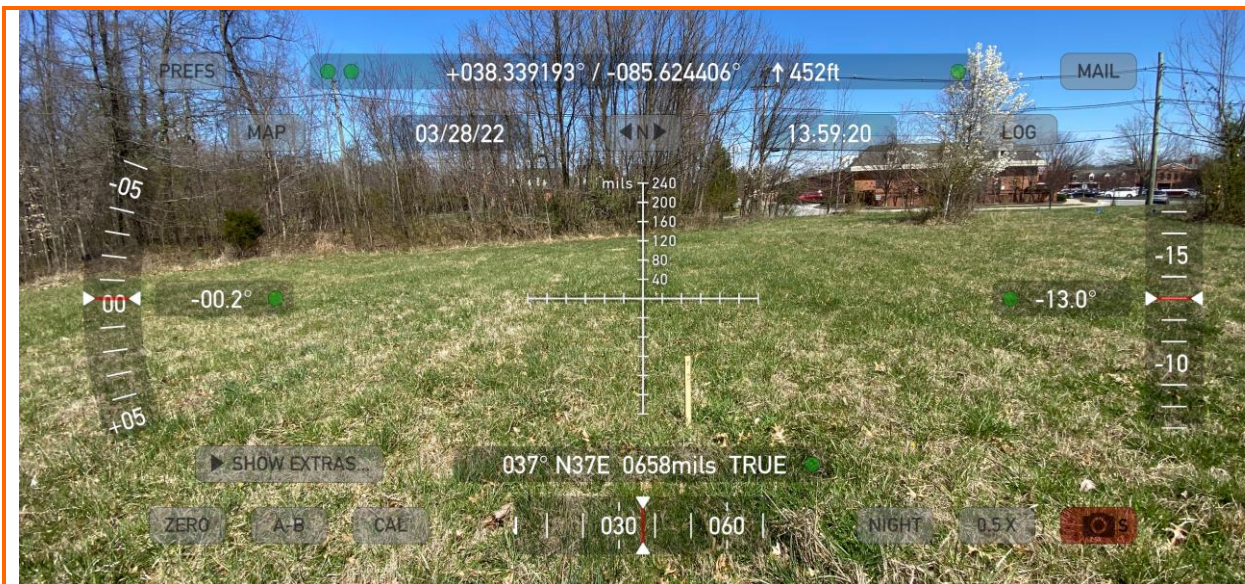
Photo 13: CPT Sounding B-2, looking northeast

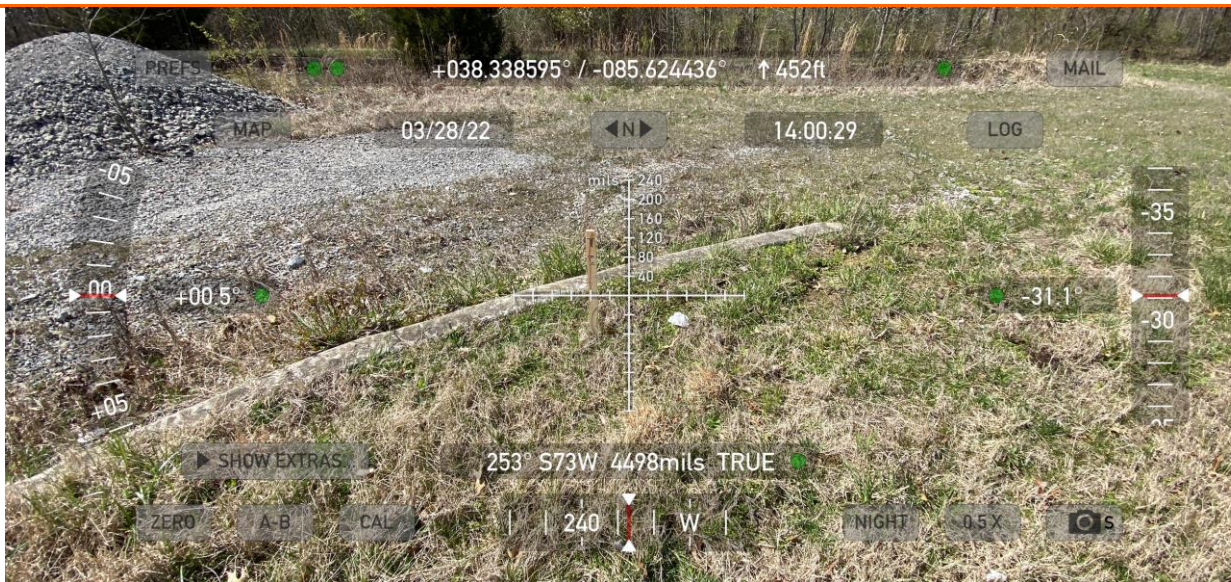
Photo 14: Boring B-3, looking southwest

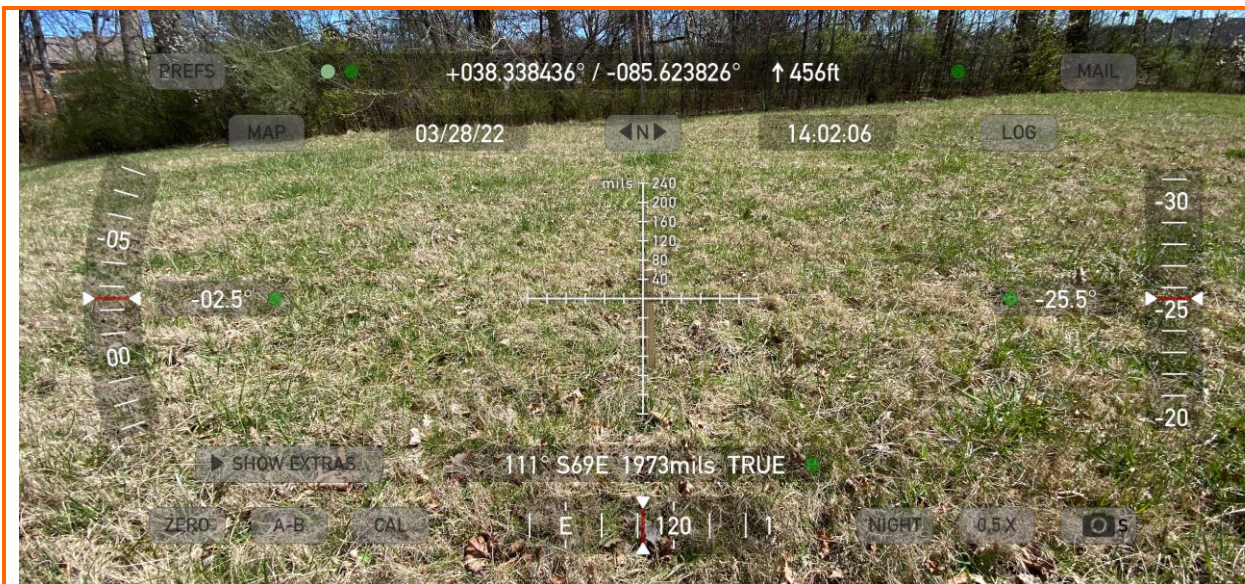
Photo 15: Boring B-4, looking southeast

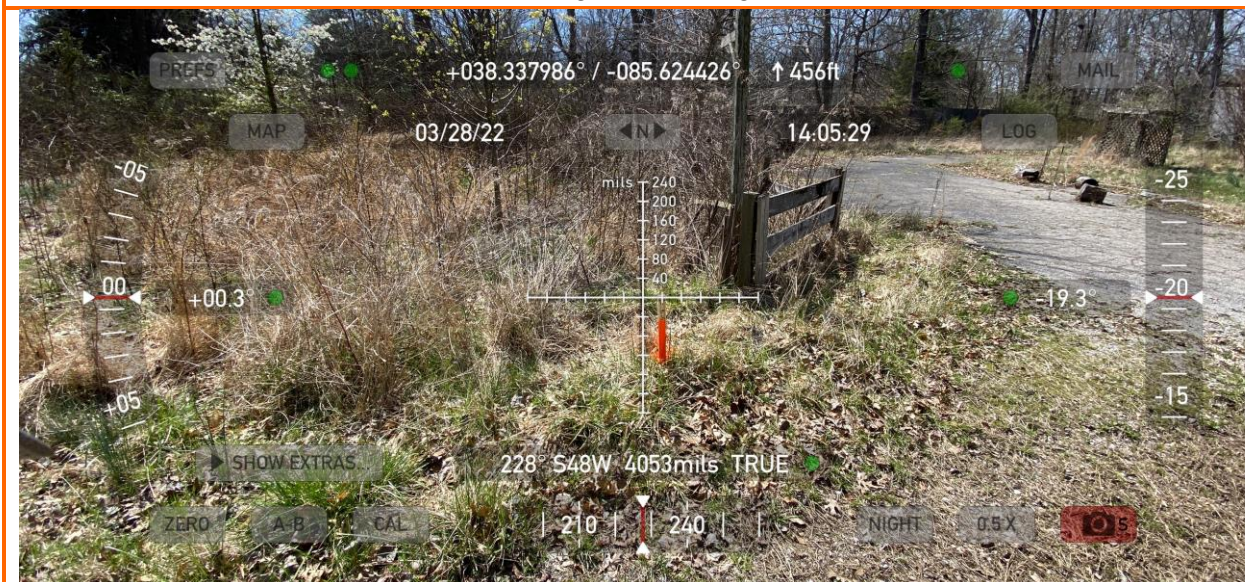
Photo 16: Boring B-5, looking southwest
