## Historic Landmarks and Preservation Districts Commission

# Report to the Committee

**Case No:** 25-COA-0057  
**Classification:** Committee Review

**Property Address:** 1412 Willow Ave. Units 21, 22, 32, 34, 35, 37, & common areas  
1416 Willow Ave. Units 2A, 2B, 3A, 3B, & common areas

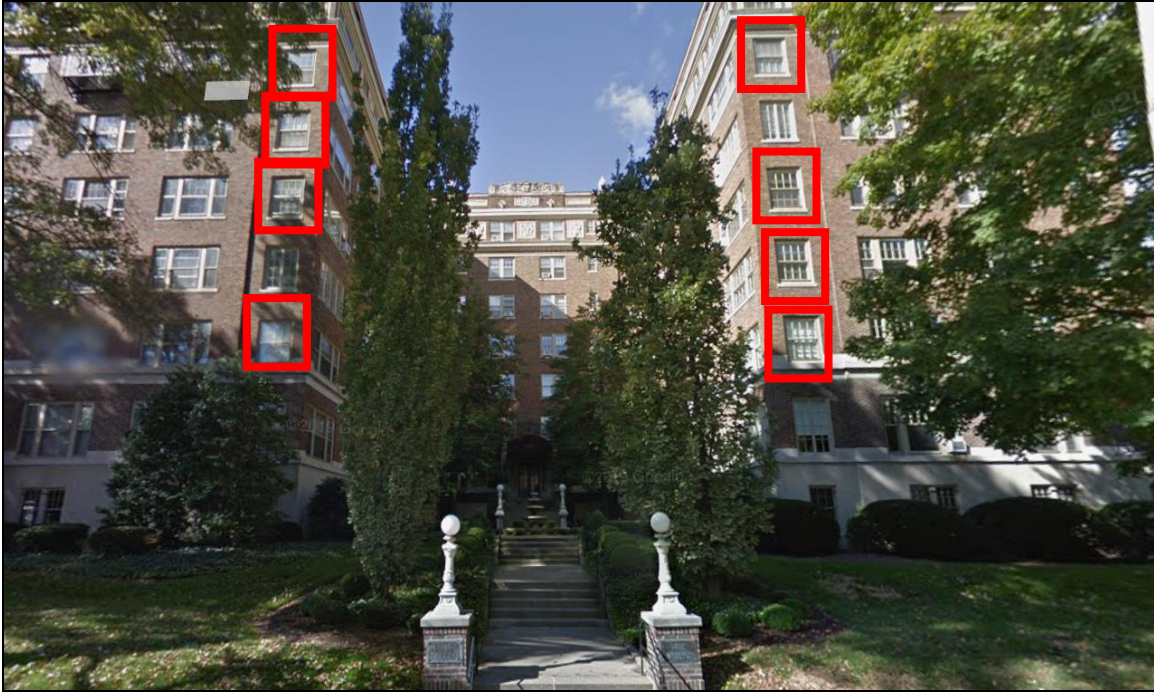
Figure 2 – Google Street View, Oct 2018, of 1412 Willow Ave. (red squares indicates a 16-lite casement window previously replaced with a 16-lite double-hung window).
